S19-948

**Folkingham Road,
Vine Street, West
Road,
Billingborough**

Section 19 Flood and Water
Management Act 2010

GeoSmart Information Ltd

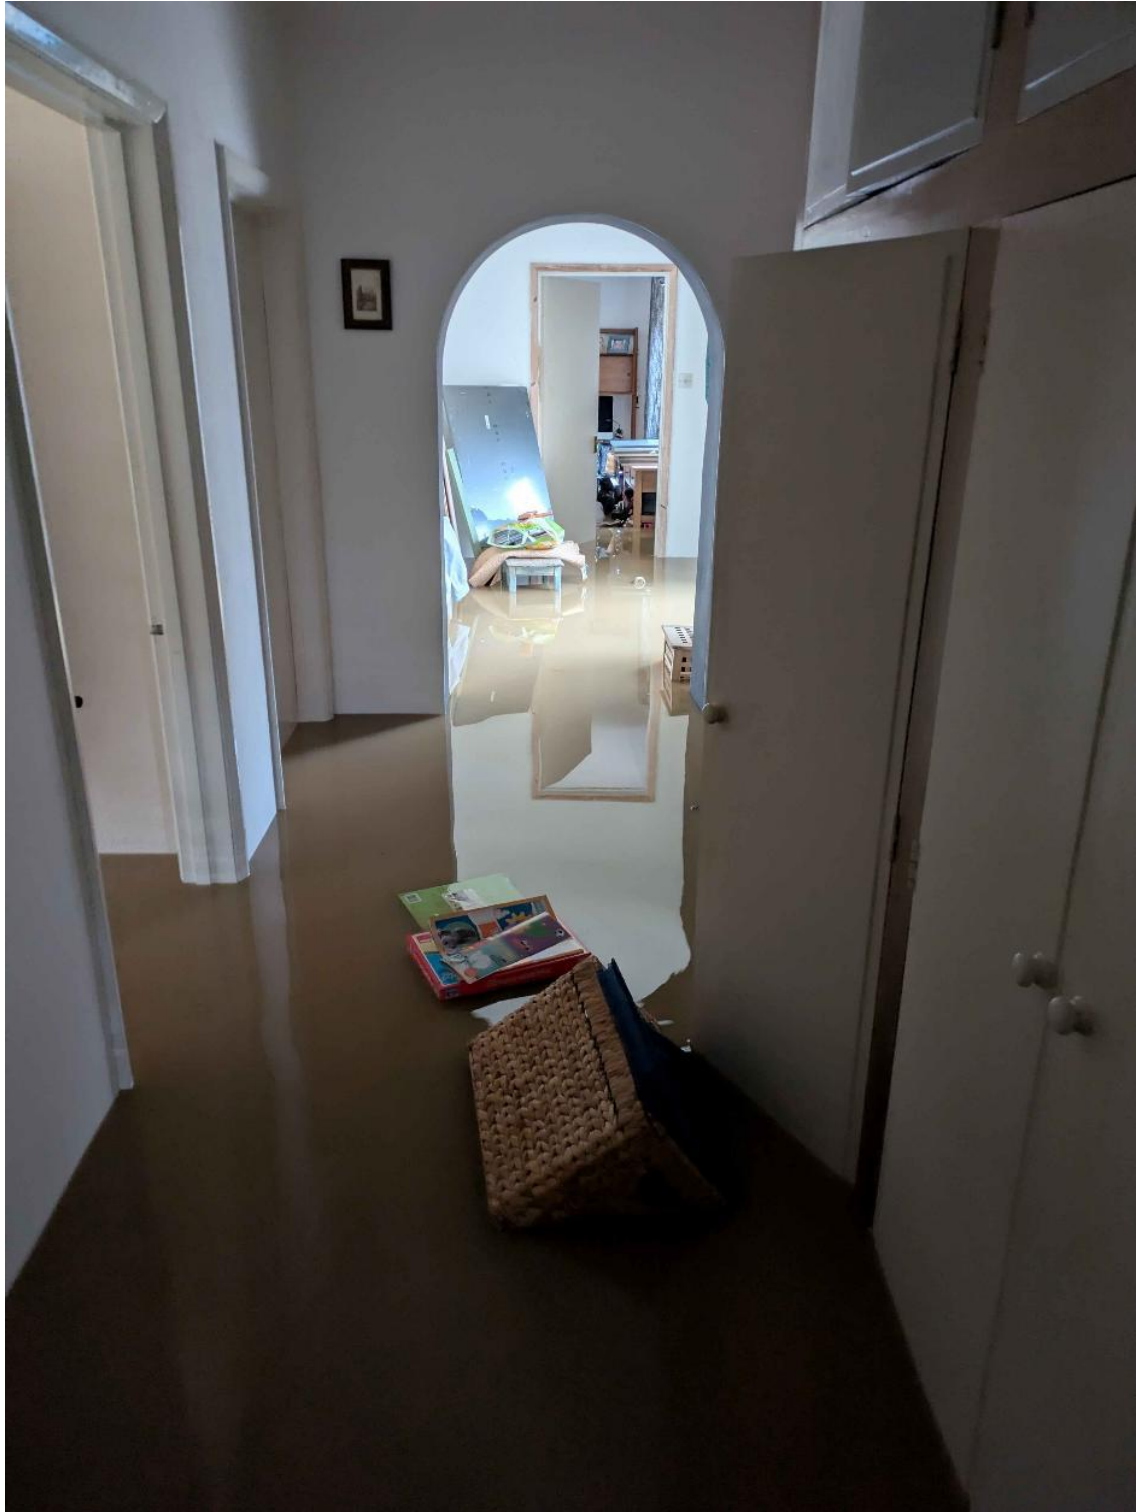
(Figure 13 - Flooding of the ground floor within Property A) (Taken by resident of Property A, 06 January 2025)

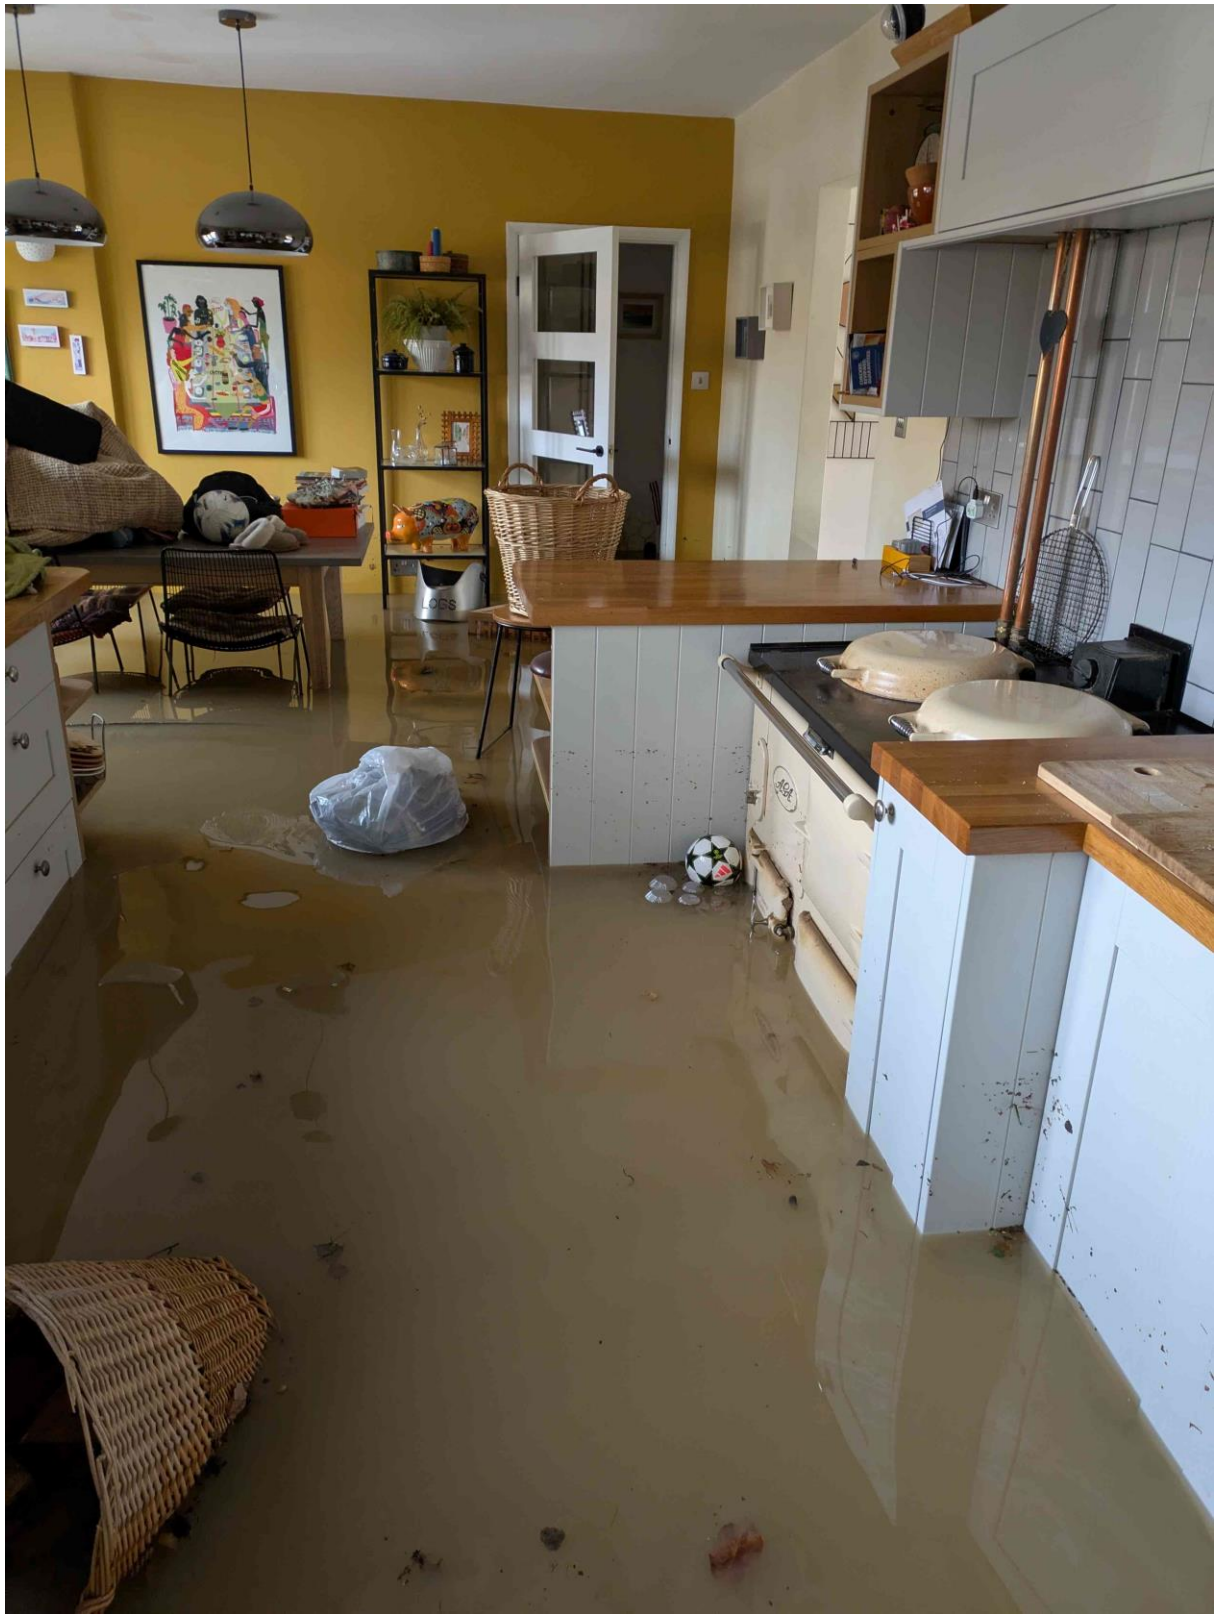
(Figure 14 - Flooding of the kitchen within Property A) (Taken by resident of Property A, 06 January 2025)

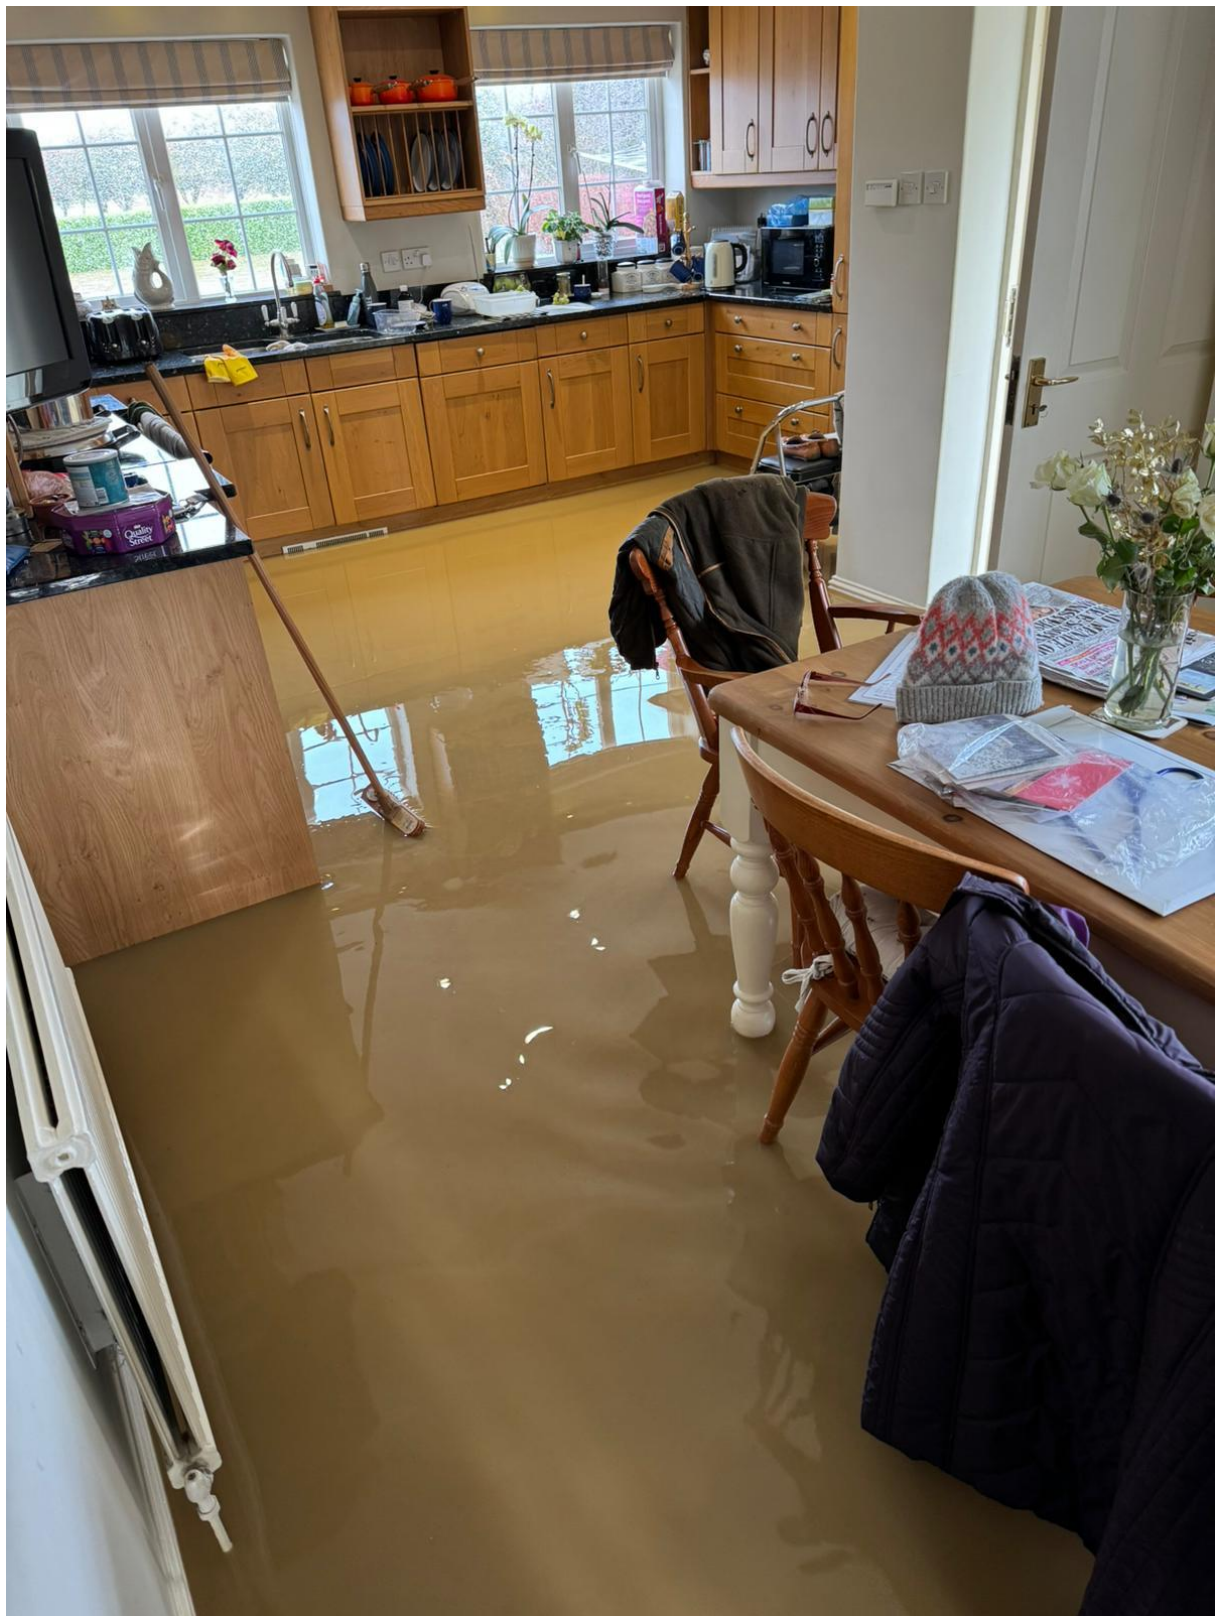
(Figure 15 - Flooding of the kitchen within Property G) (Taken by resident of Property G, 06 January 2025)

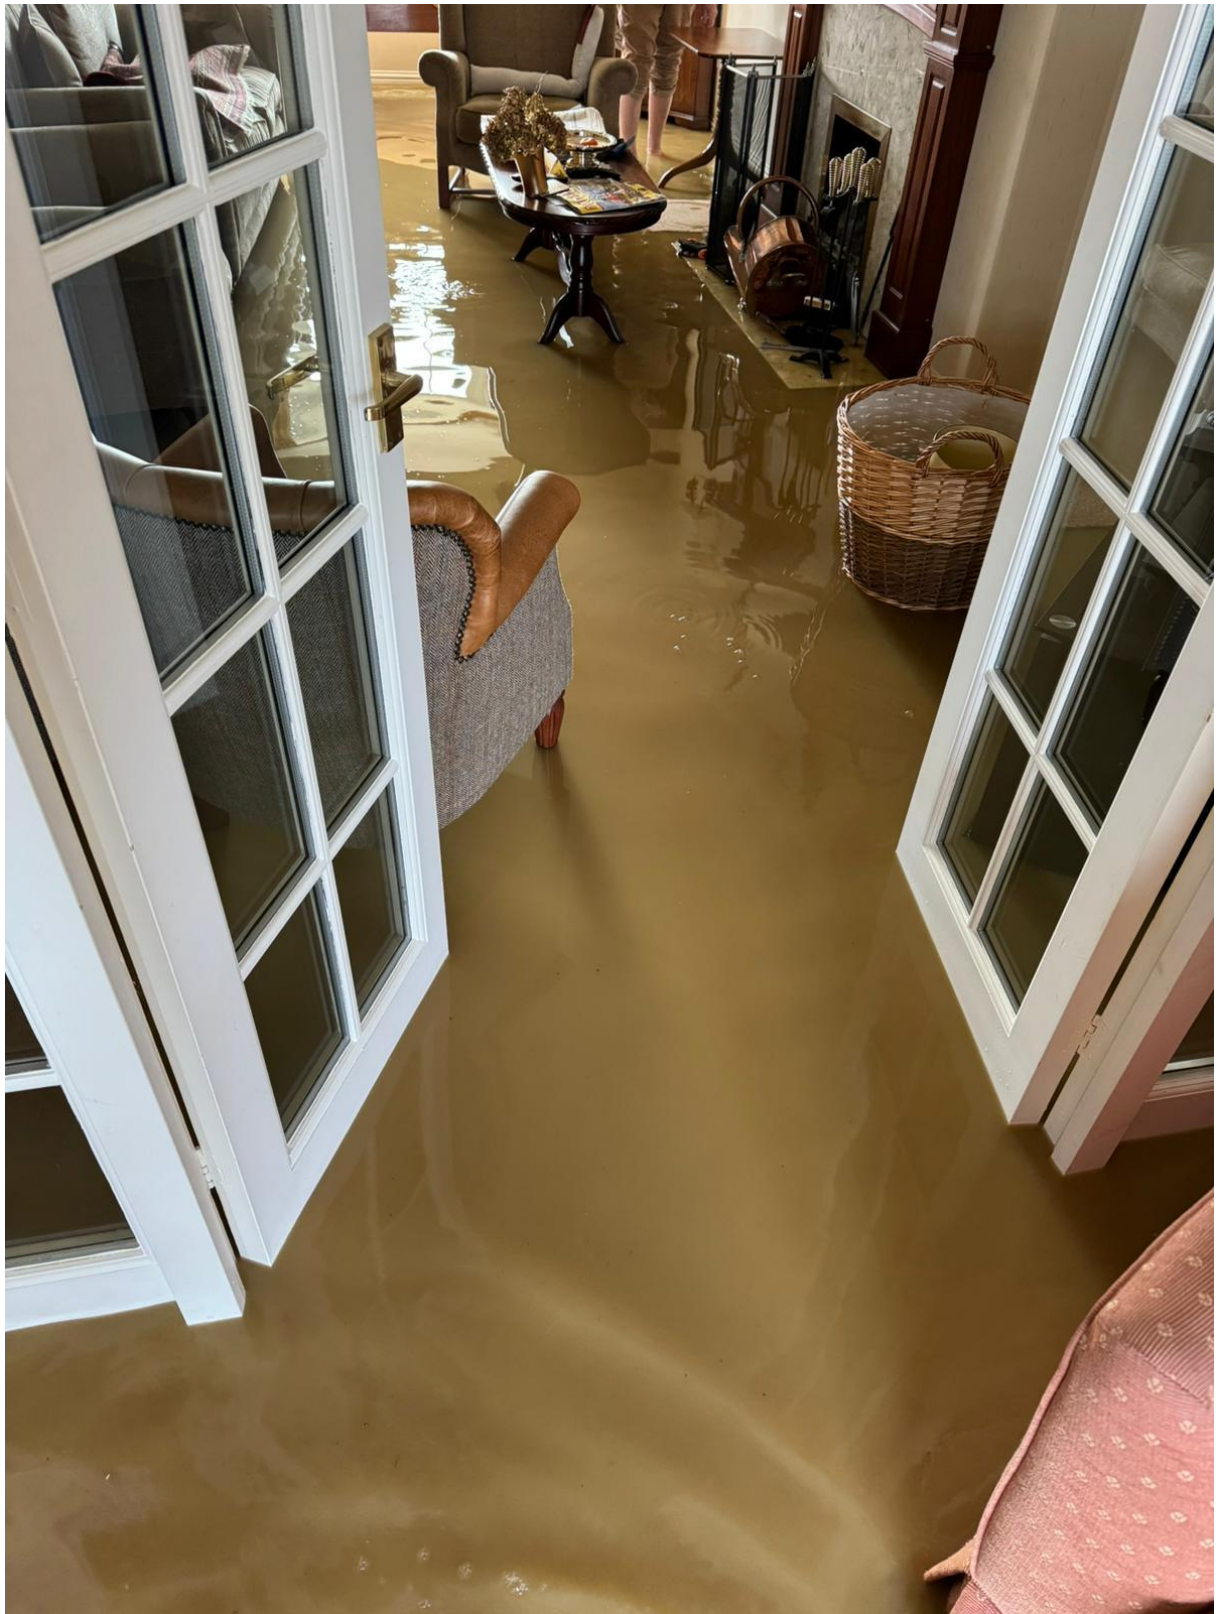
(Figure 16 - Flooding of ground floor within Property G) (Taken by resident of Property G, 06 January 2025)

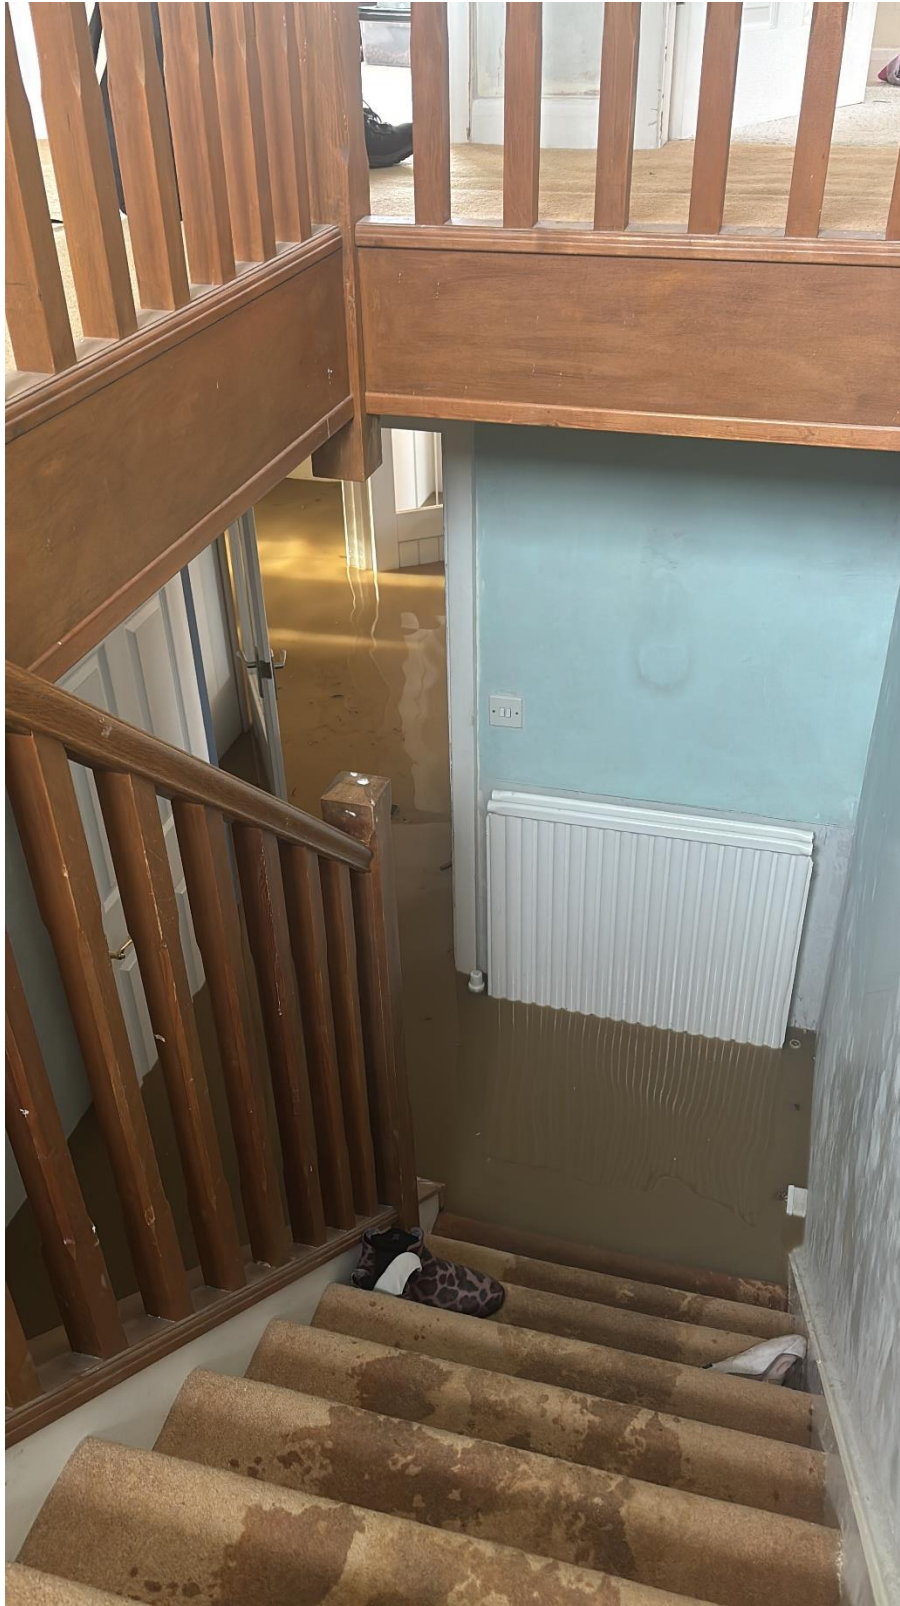
(Figure 17 - Flooding of the ground floor within Property I) (Taken by resident of Property I, 06 January 2025)

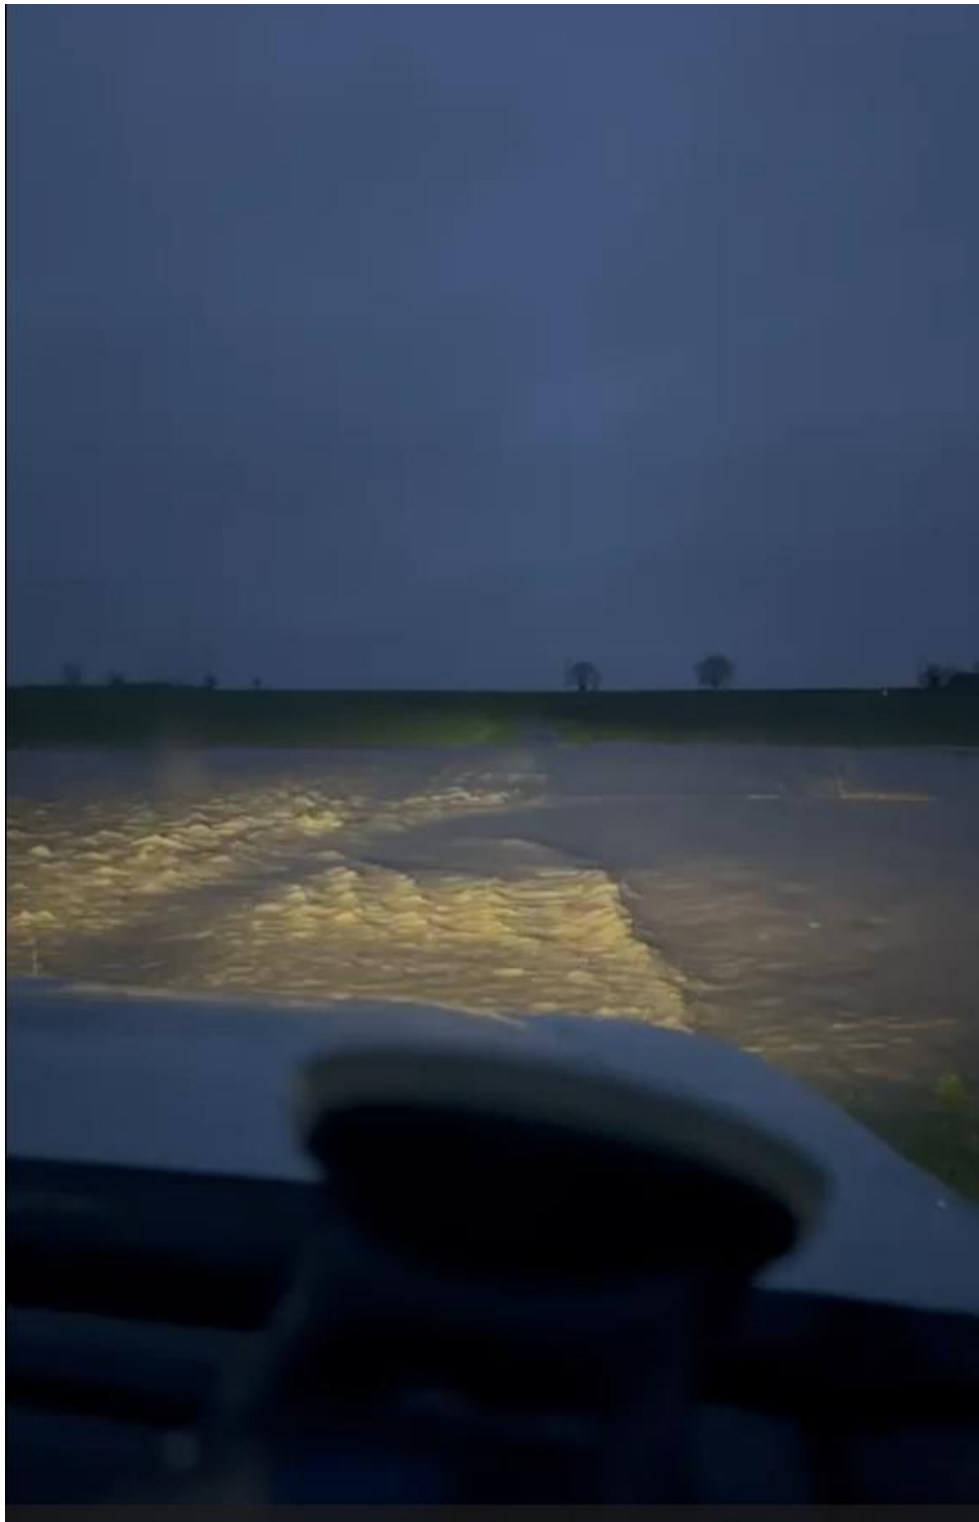
(Figure 18 - Overtopping of the Ousemere Lode making Oseby Lane impassable) (Taken by resident of Billingborough who sent video footage to LCC, 06 January 2025).

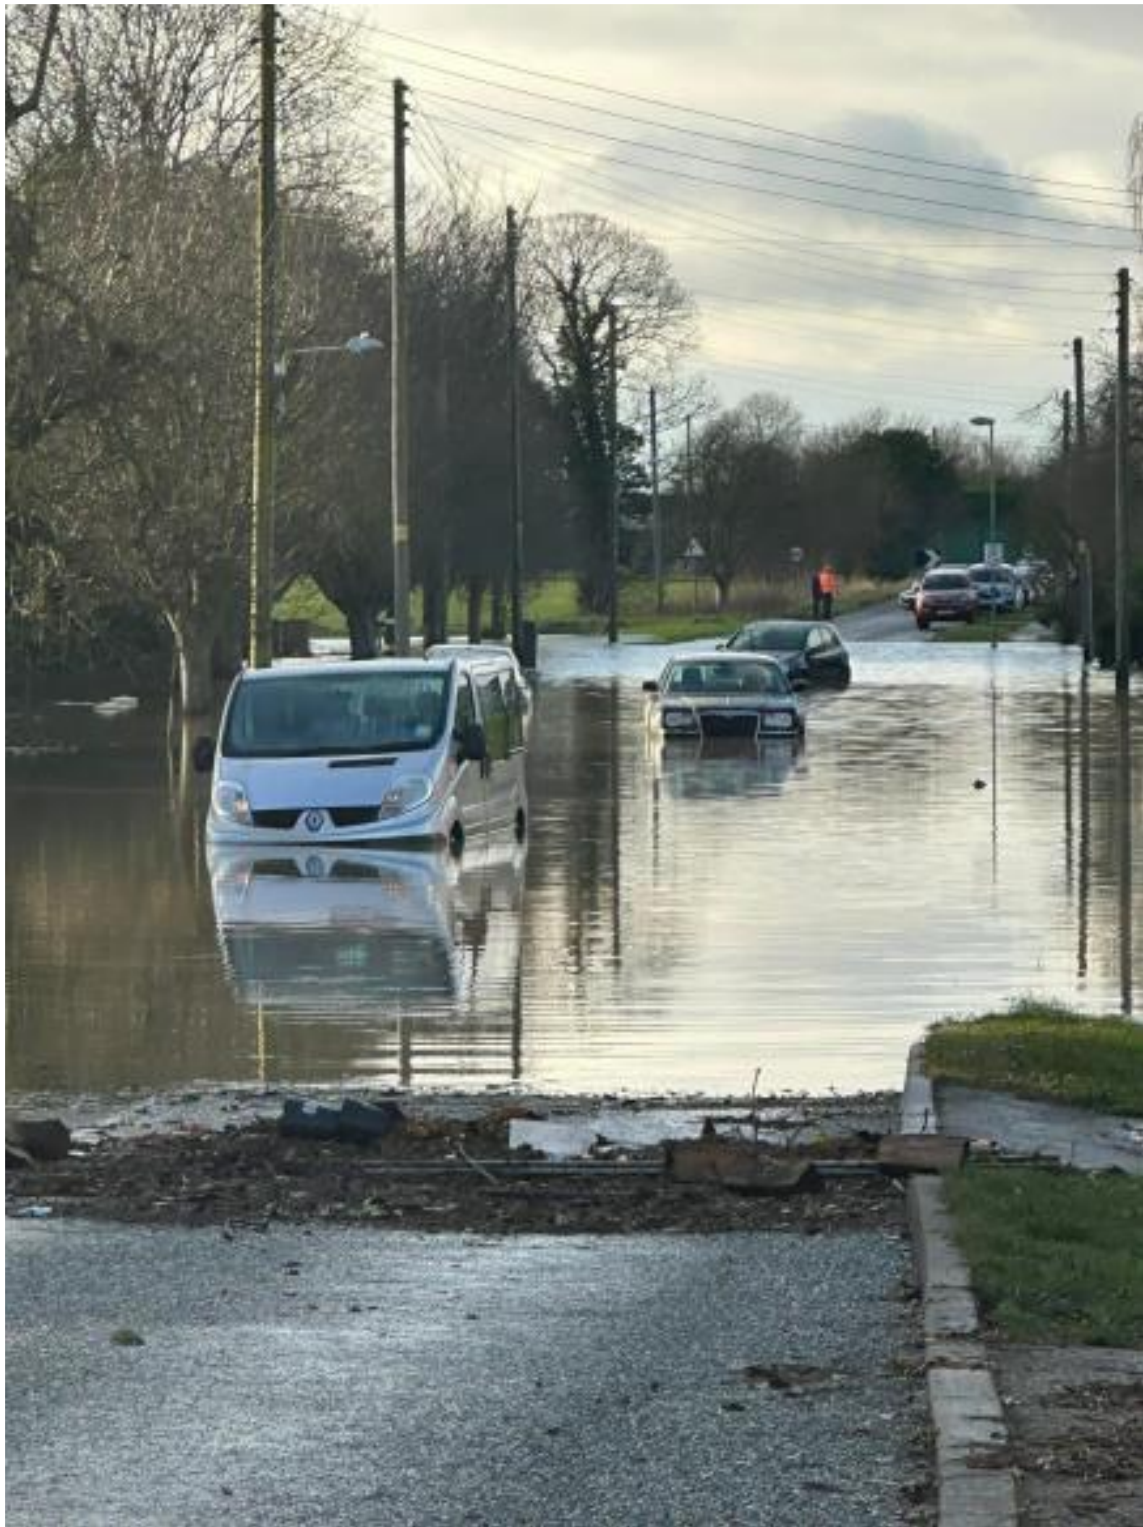
(Figure 20 - Ponded water within Folkingham Road on 07 January) (Taken by resident of Folkingham Road, 07 January 2025).

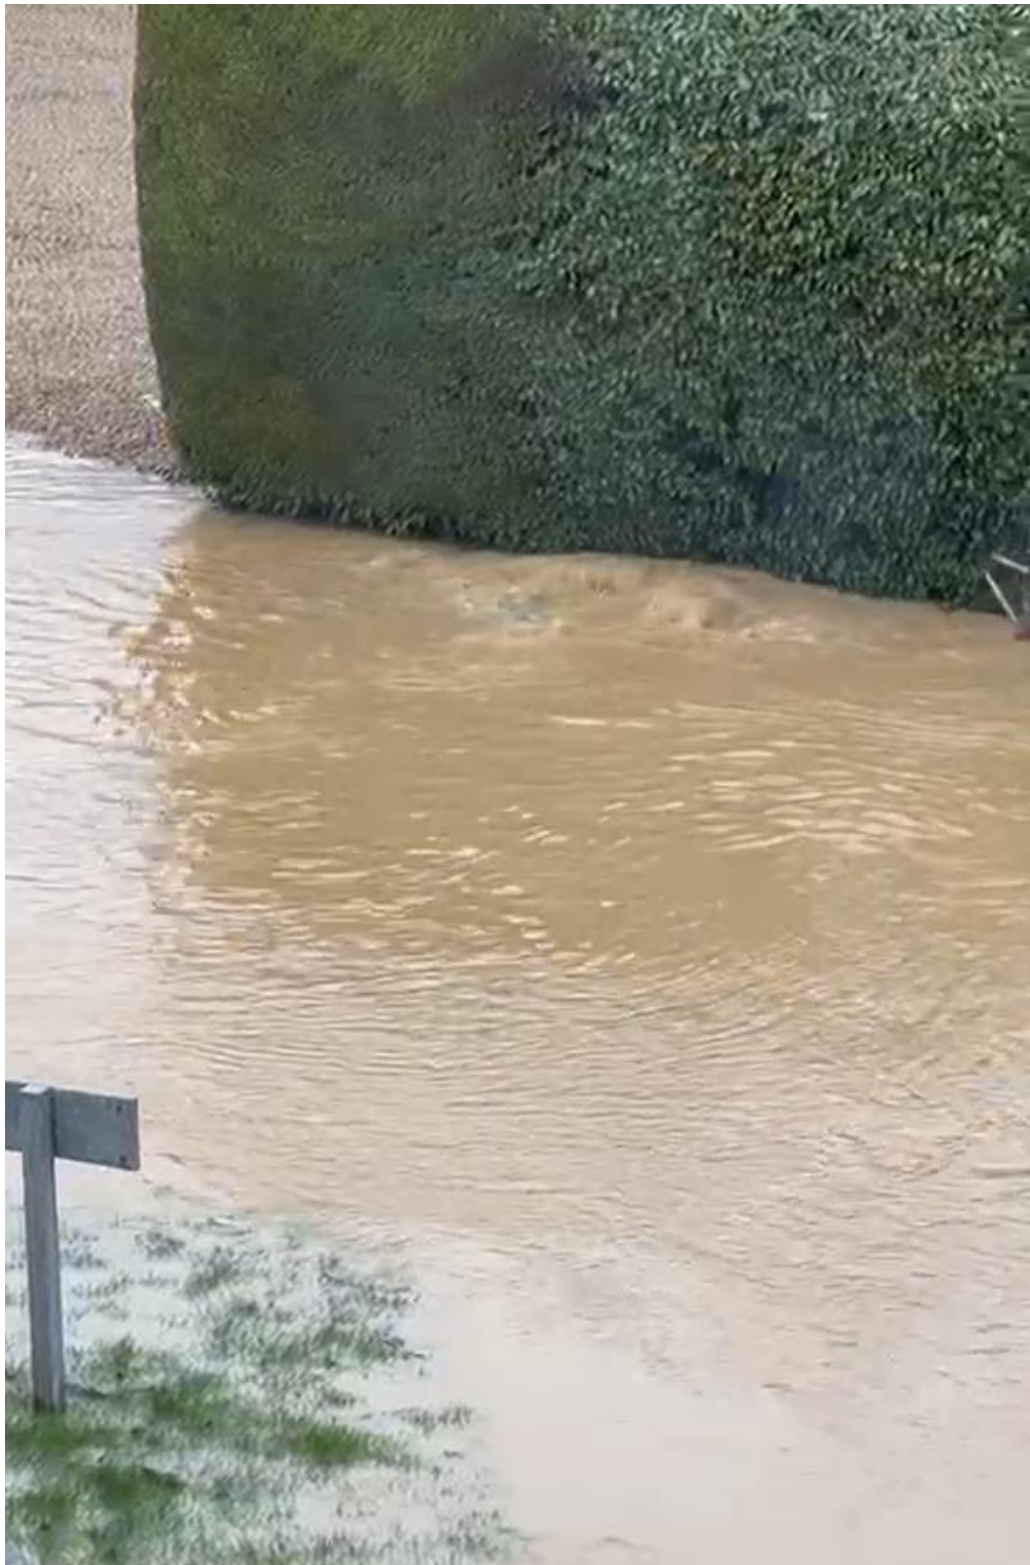
(Figure 22 - Surcharging manhole cover within Vine Court) (Taken by Billingborough resident, 06 January, 2025).

In addition, a wider review of the surface water drainage network across Billingborough should be considered, particularly in light of multiple reports of surcharging manholes. This would help assess whether the network has sufficient capacity under extreme conditions.

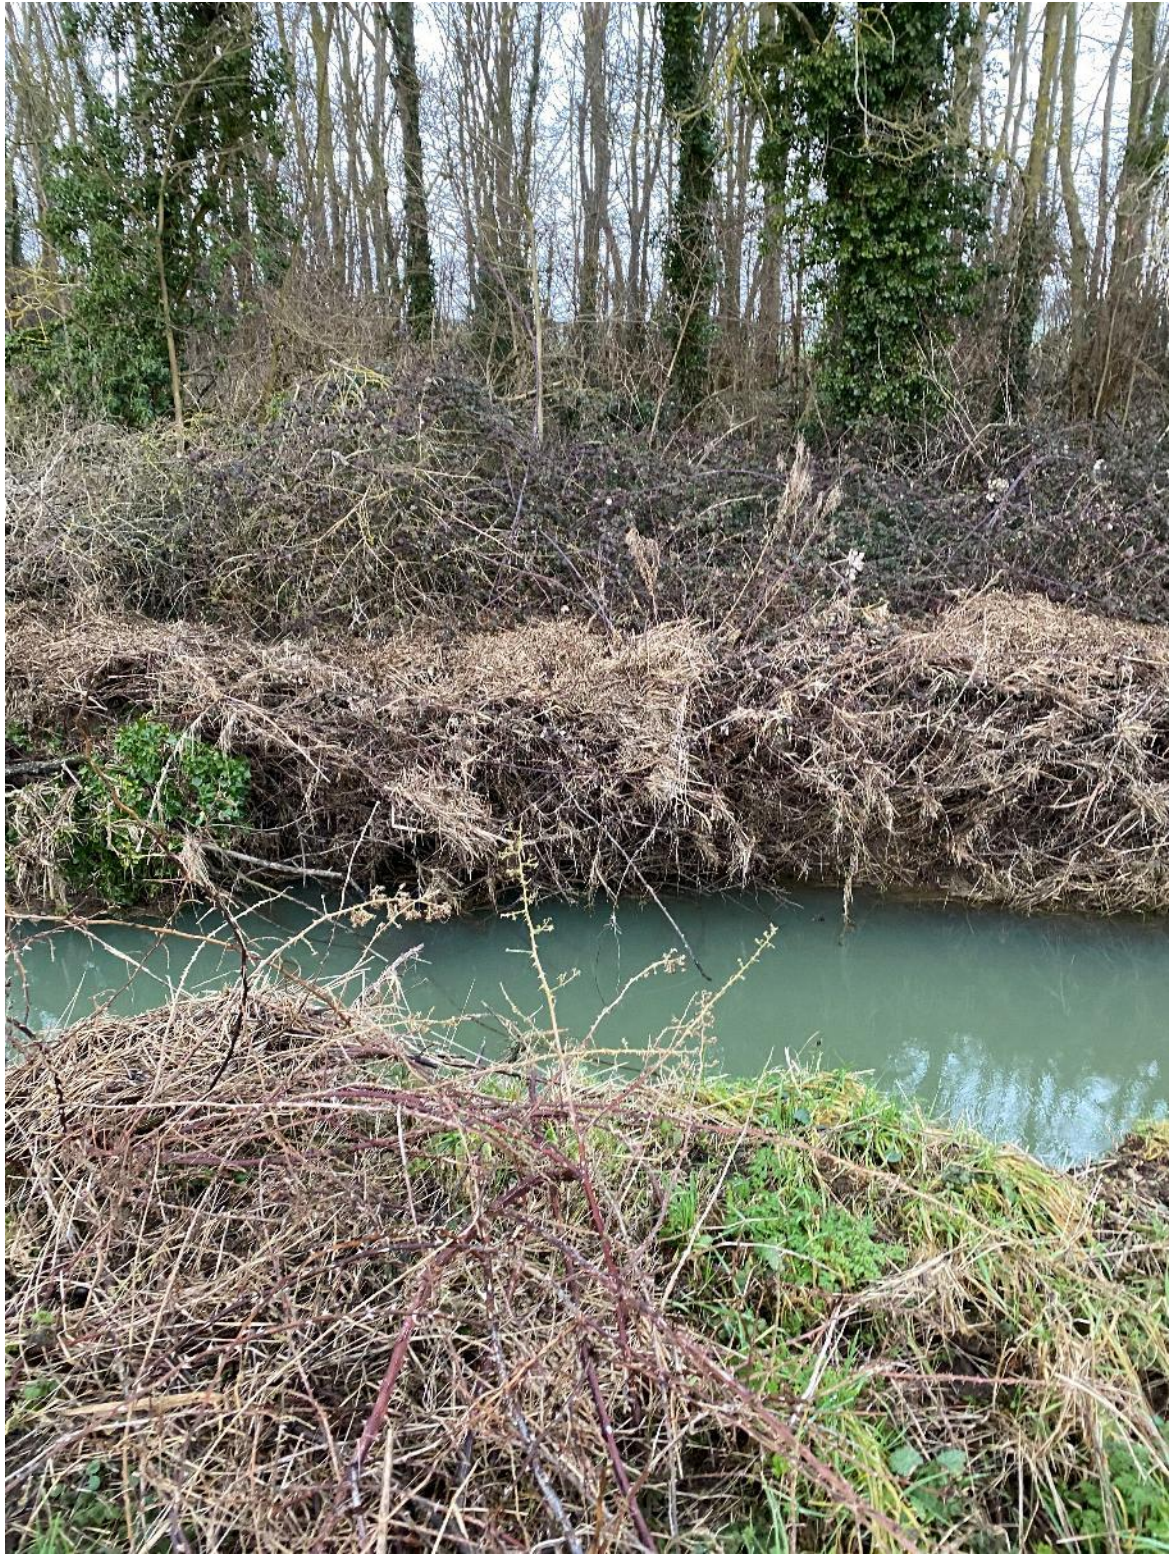
(Photograph 1 - Straw trash lines visible along the Ousemere Lode during site visit) (Taken by GeoSmart Consultant, 12 February 2025).

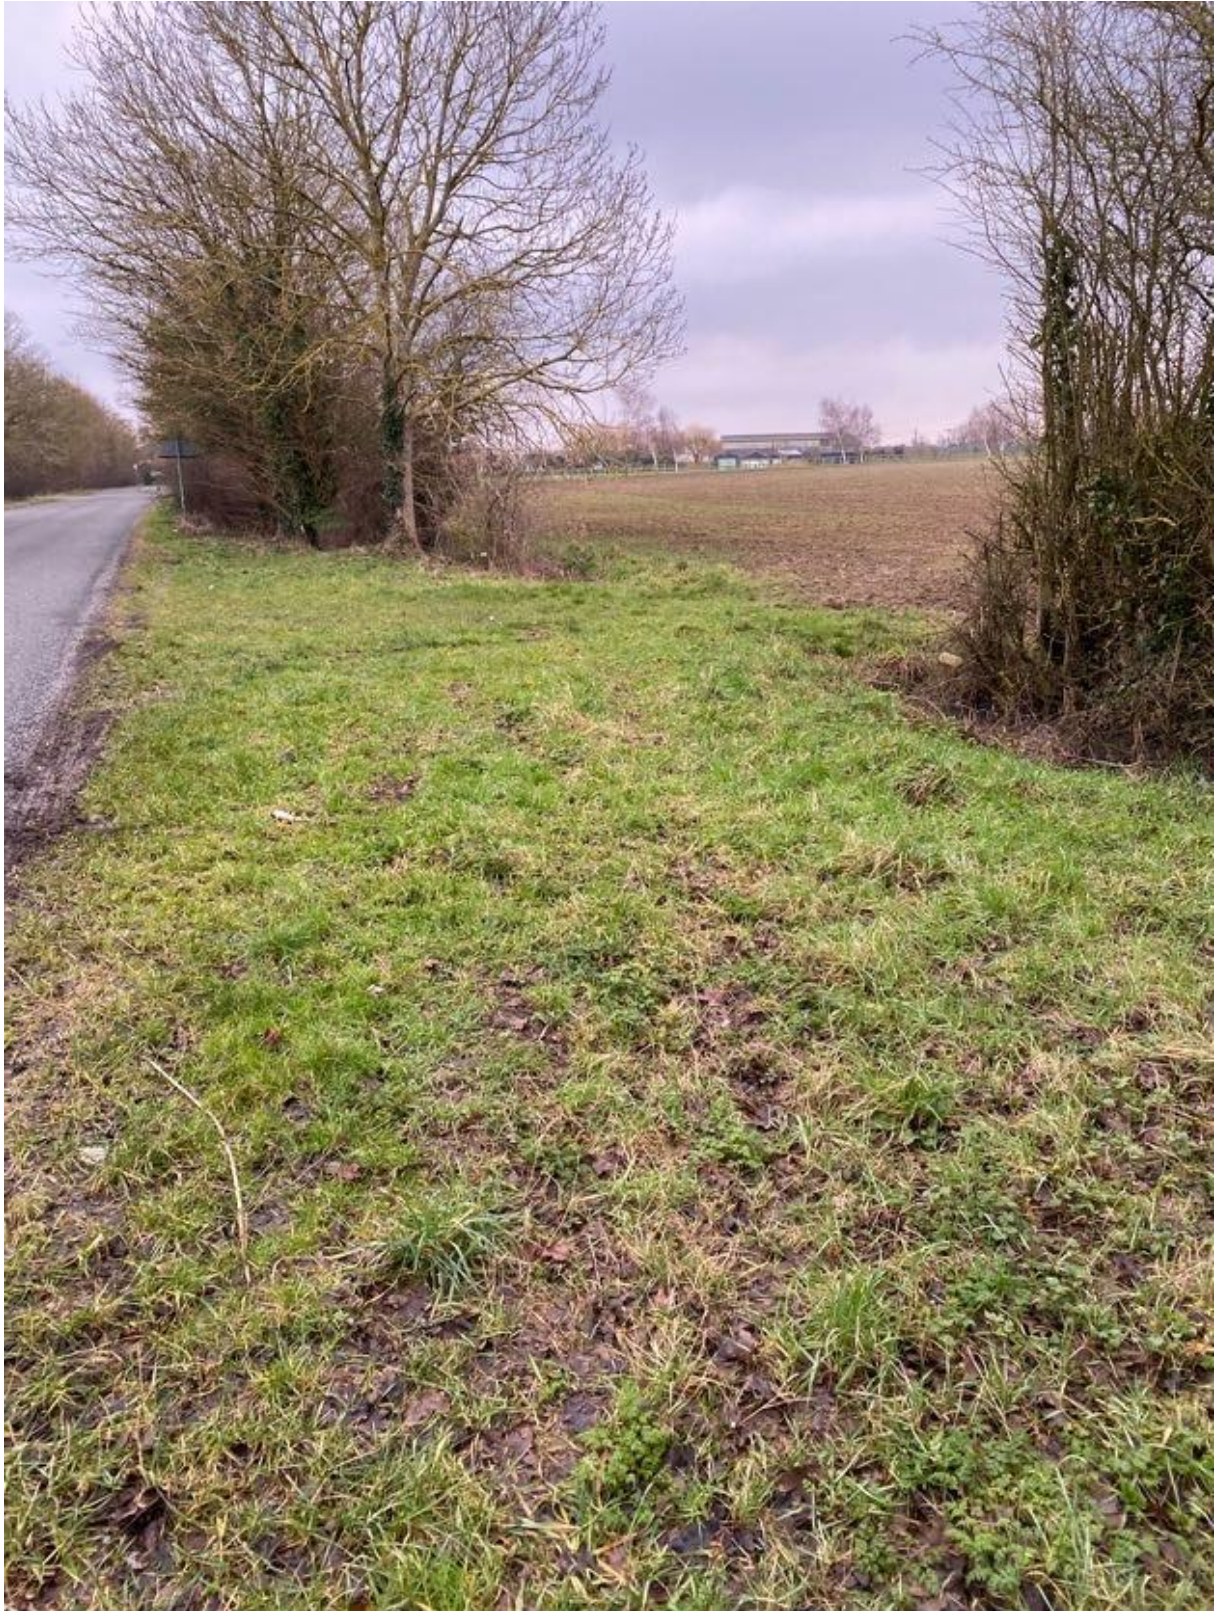
(Photograph 2 - Straw debris outside of Piperdam Bridge facing Billinghamborough) (Taken by GeoSmart Consultant, 12 February 2025).

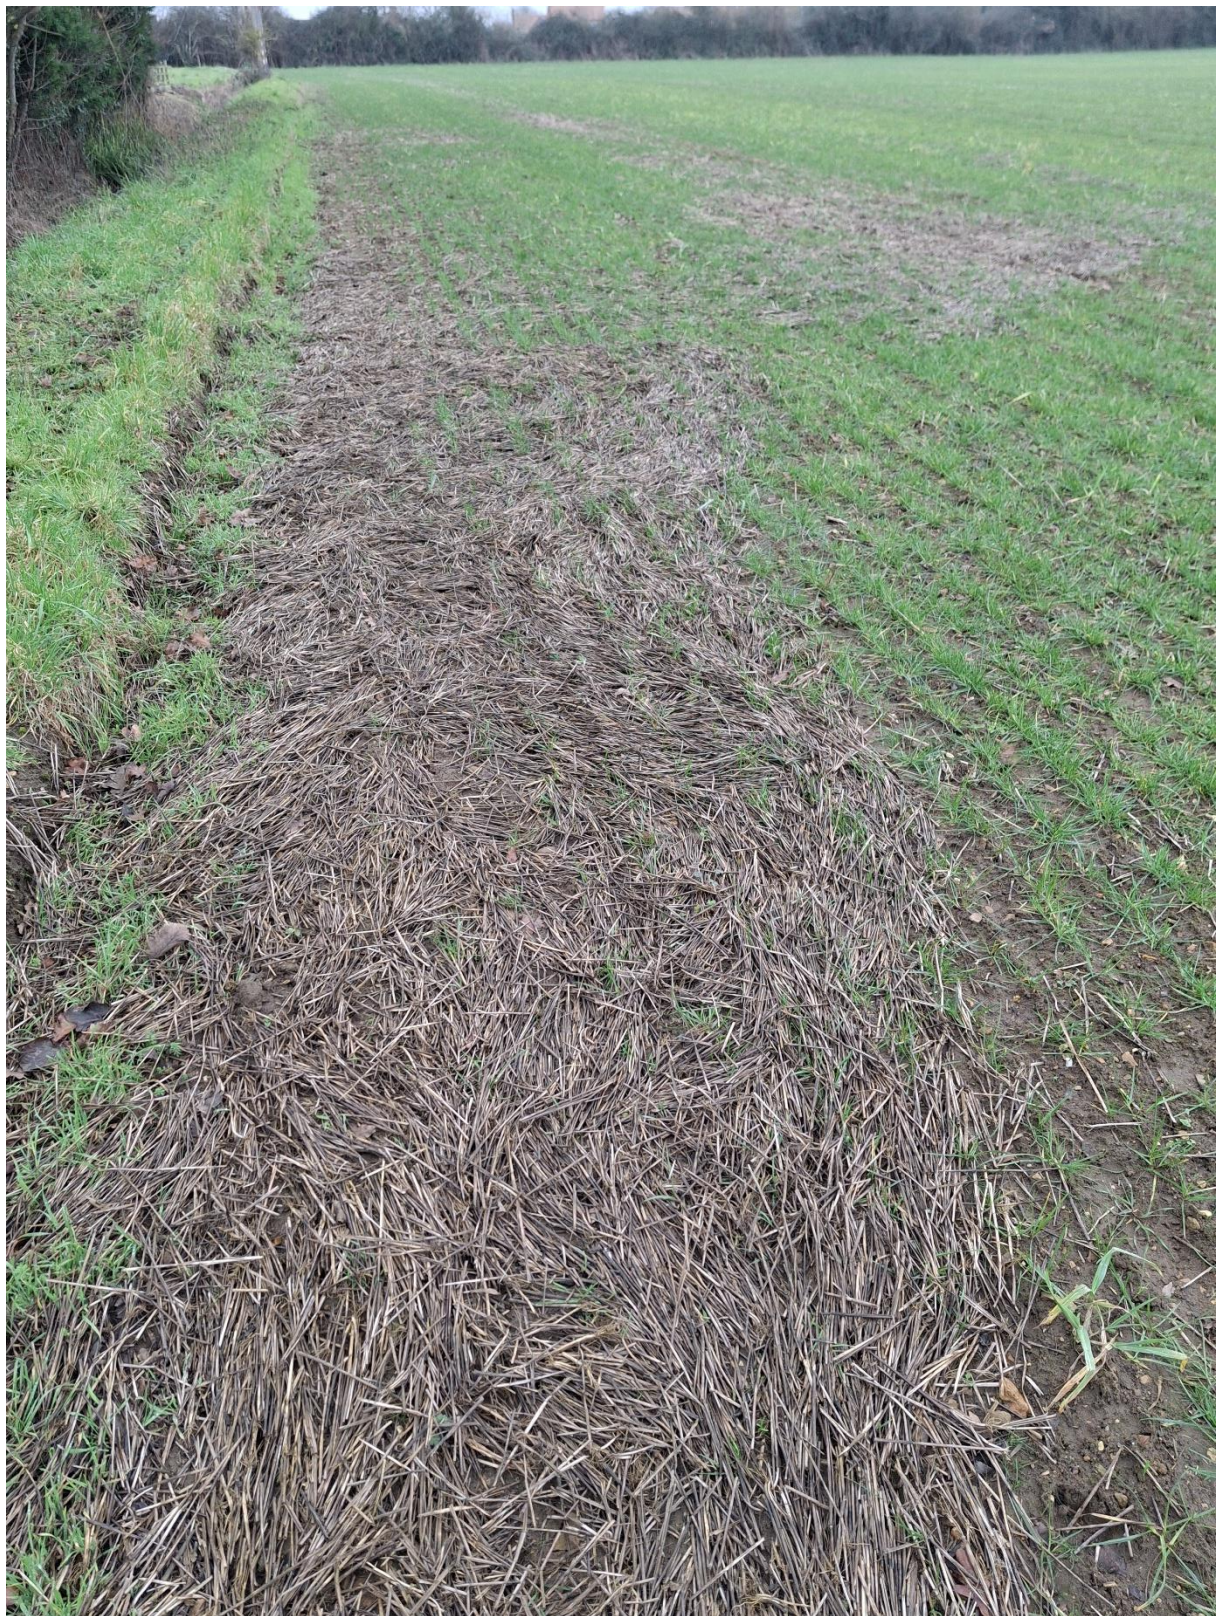
(Photograph 3 - Straw accumulation in fields south west of Folkingham Road) (Taken by GeoSmart Consultant, 12 February 2025).

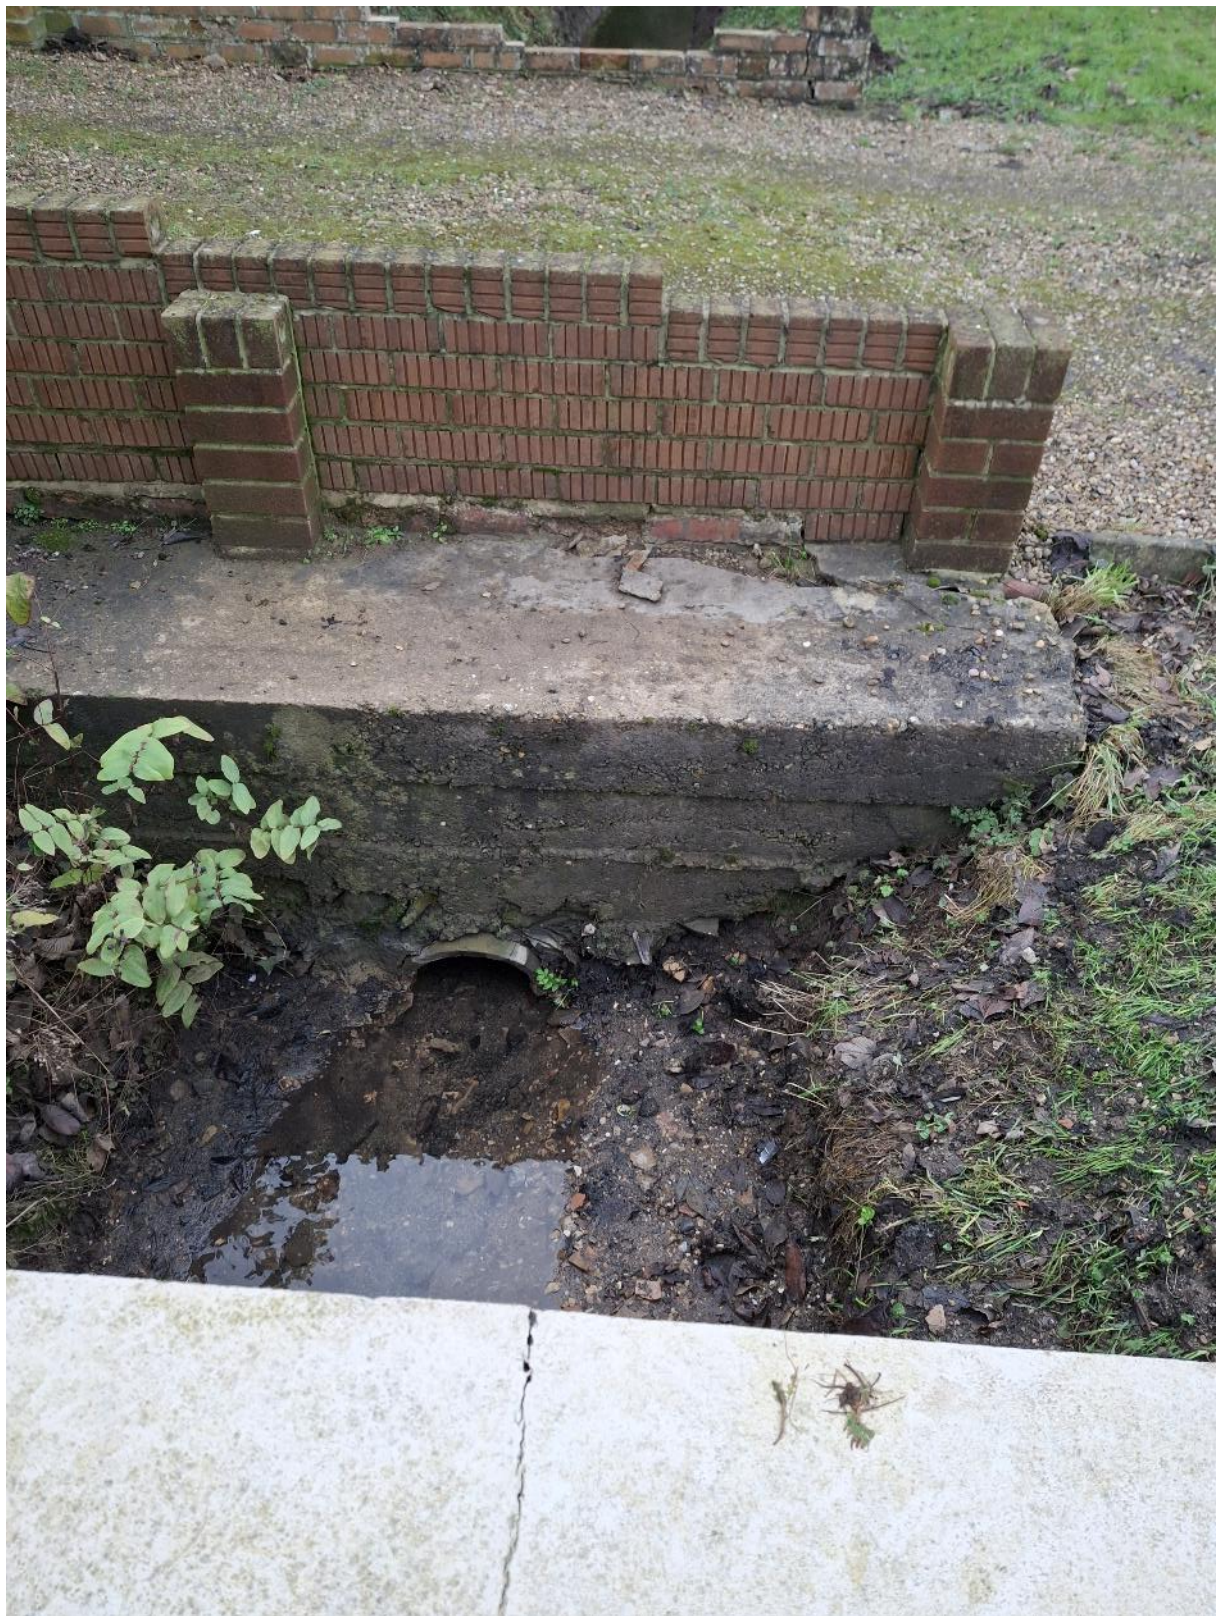
The roadside drainage ditches along Folkingham Road were found to be in variable condition. Sections along the northern edge, in particular, exhibited significant accumulations of silt, leaf litter, and vegetation, resulting in the obstruction of much of the associated culvert pipework (Photograph 4 in Appendix 7.3). In contrast, ditches to the south were generally clearer, though localised silt accumulation was still present which may reduce operational capacity (Photograph 5 in Appendix 7.3).

(Photograph 4 - Drainage ditch heavily accumulated with silt on Folkingham Road) (Taken by GeoSmart Consultant, 12 February 2025).

Although some residents had begun excavating and maintaining the drainage ditches at the time of the site visit, it was evident that several ditches remained partially blocked or had been entirely infilled. It is therefore recommended that all ditches be fully cleared as part of future works.
