S19-948

**Folkingham Road,
Vine Street, West
Road,
Billingborough**

Section 19 Flood and Water
Management Act 2010

GeoSmart Information Ltd

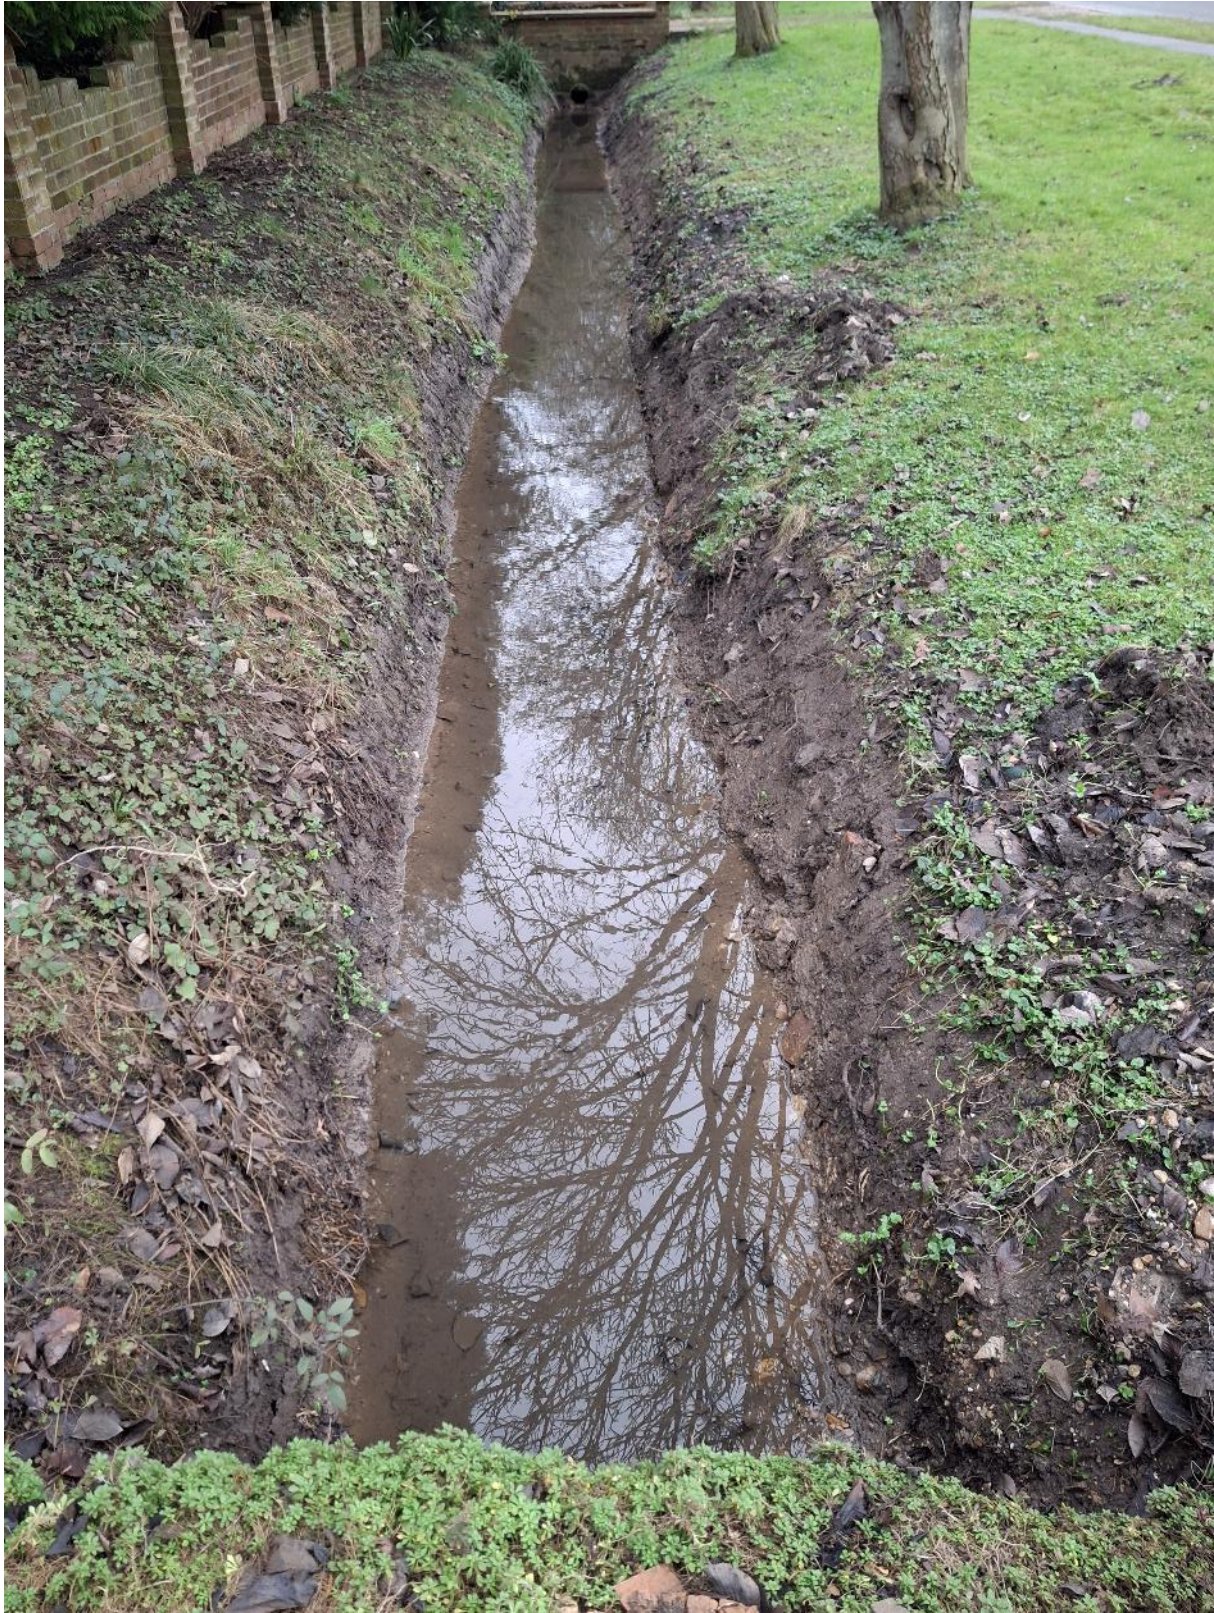
During the Site walkover the absence of a sufficient maintenance schedule was evident with the ditch at the frontages of properties in the majority of cases showing reduced capacity due to sediment and vegetation accumulation or, in some cases, entirely filled in (Photograph 4 in Appendix 7.3). Although some remedial excavation had been carried out by residents following the January 2025 event (Photograph 5 in Appendix 7.3), the pre-event condition of

(Photograph 5 - Drainage ditch along Folkingham Road) (Taken by GeoSmart Consultant, 12 February 2025).

Although some residents had begun excavating and maintaining the drainage ditches at the time of the site visit, it was evident that several ditches remained partially blocked or had been entirely infilled. It is therefore recommended that all ditches be fully cleared as part of future works.

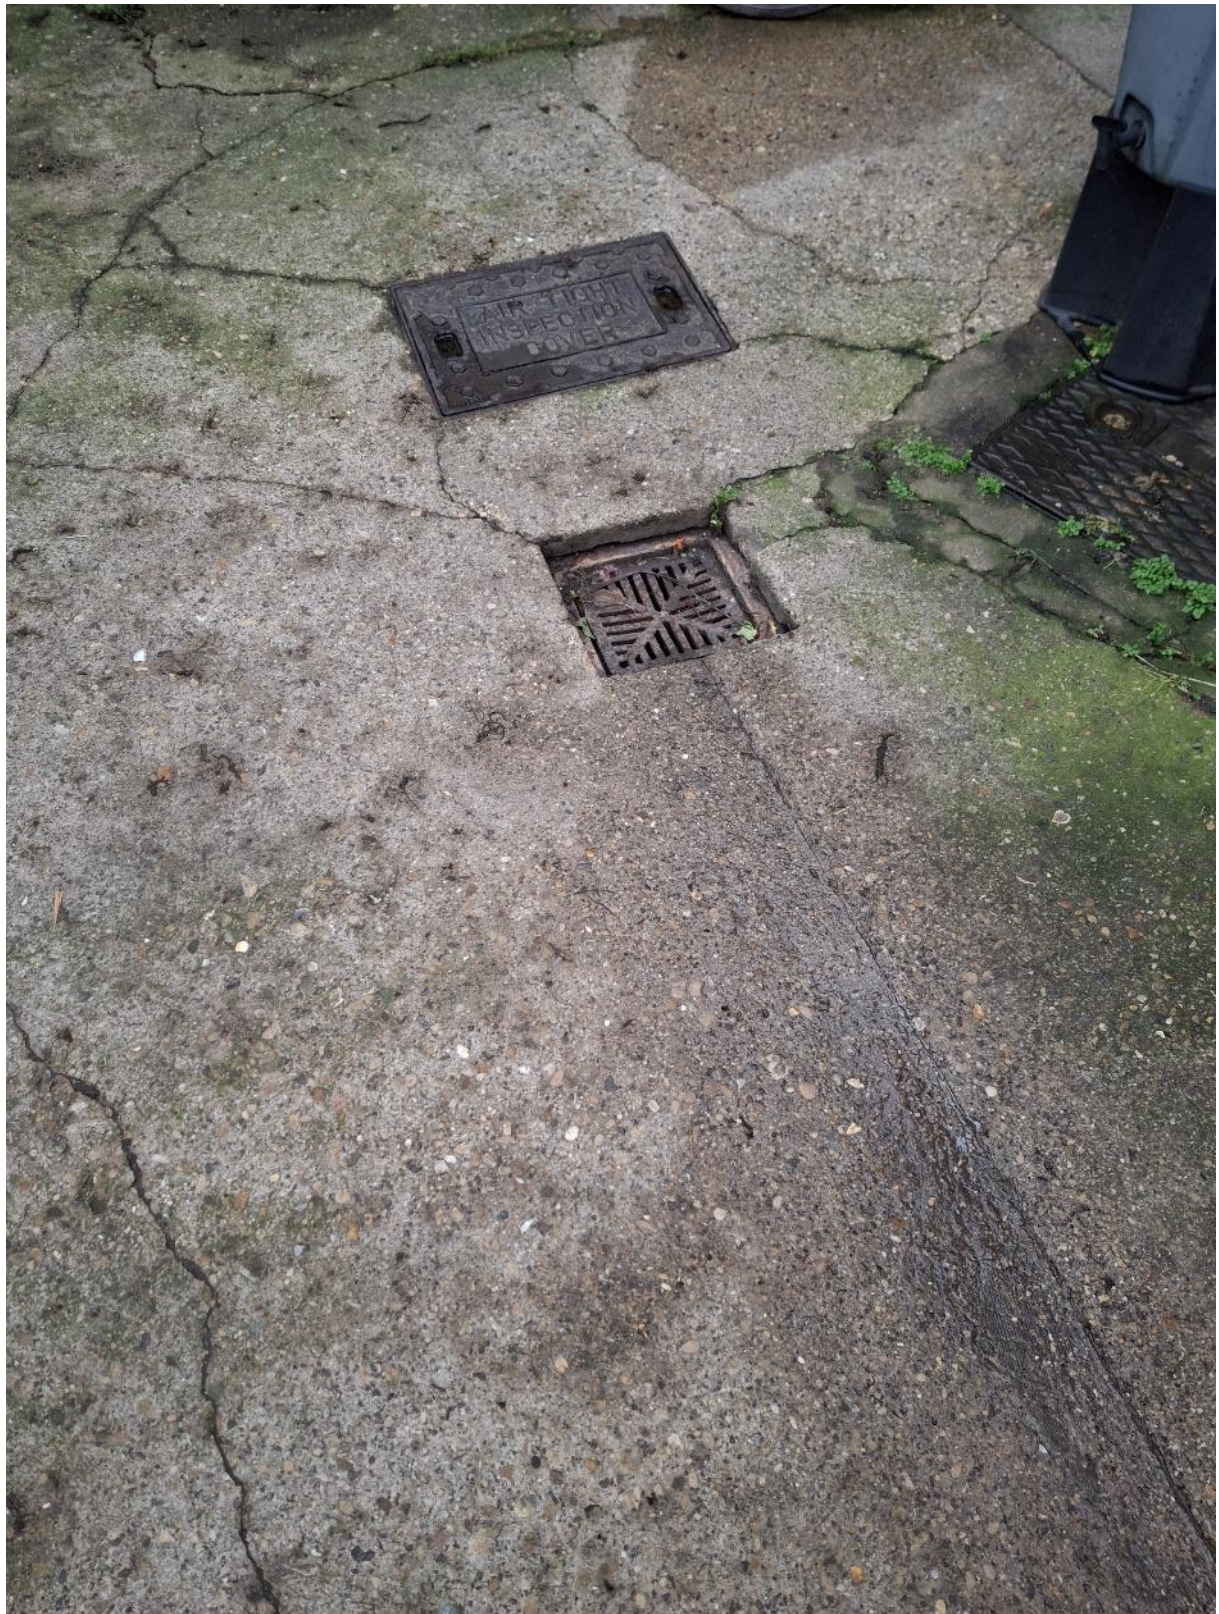
The condition of the gullies on Vine Street could not be assessed as they were obstructed by parked vehicles. Conversations with the resident of Property L indicated that flooding originated from private drainage within the rear garden, rather than from the LCC drainage network (Photograph 6 in Appendix 7.3).

(Photograph 6 - Private drainage of Property L) (Taken by GeoSmart Consultant, 12 February 2025).

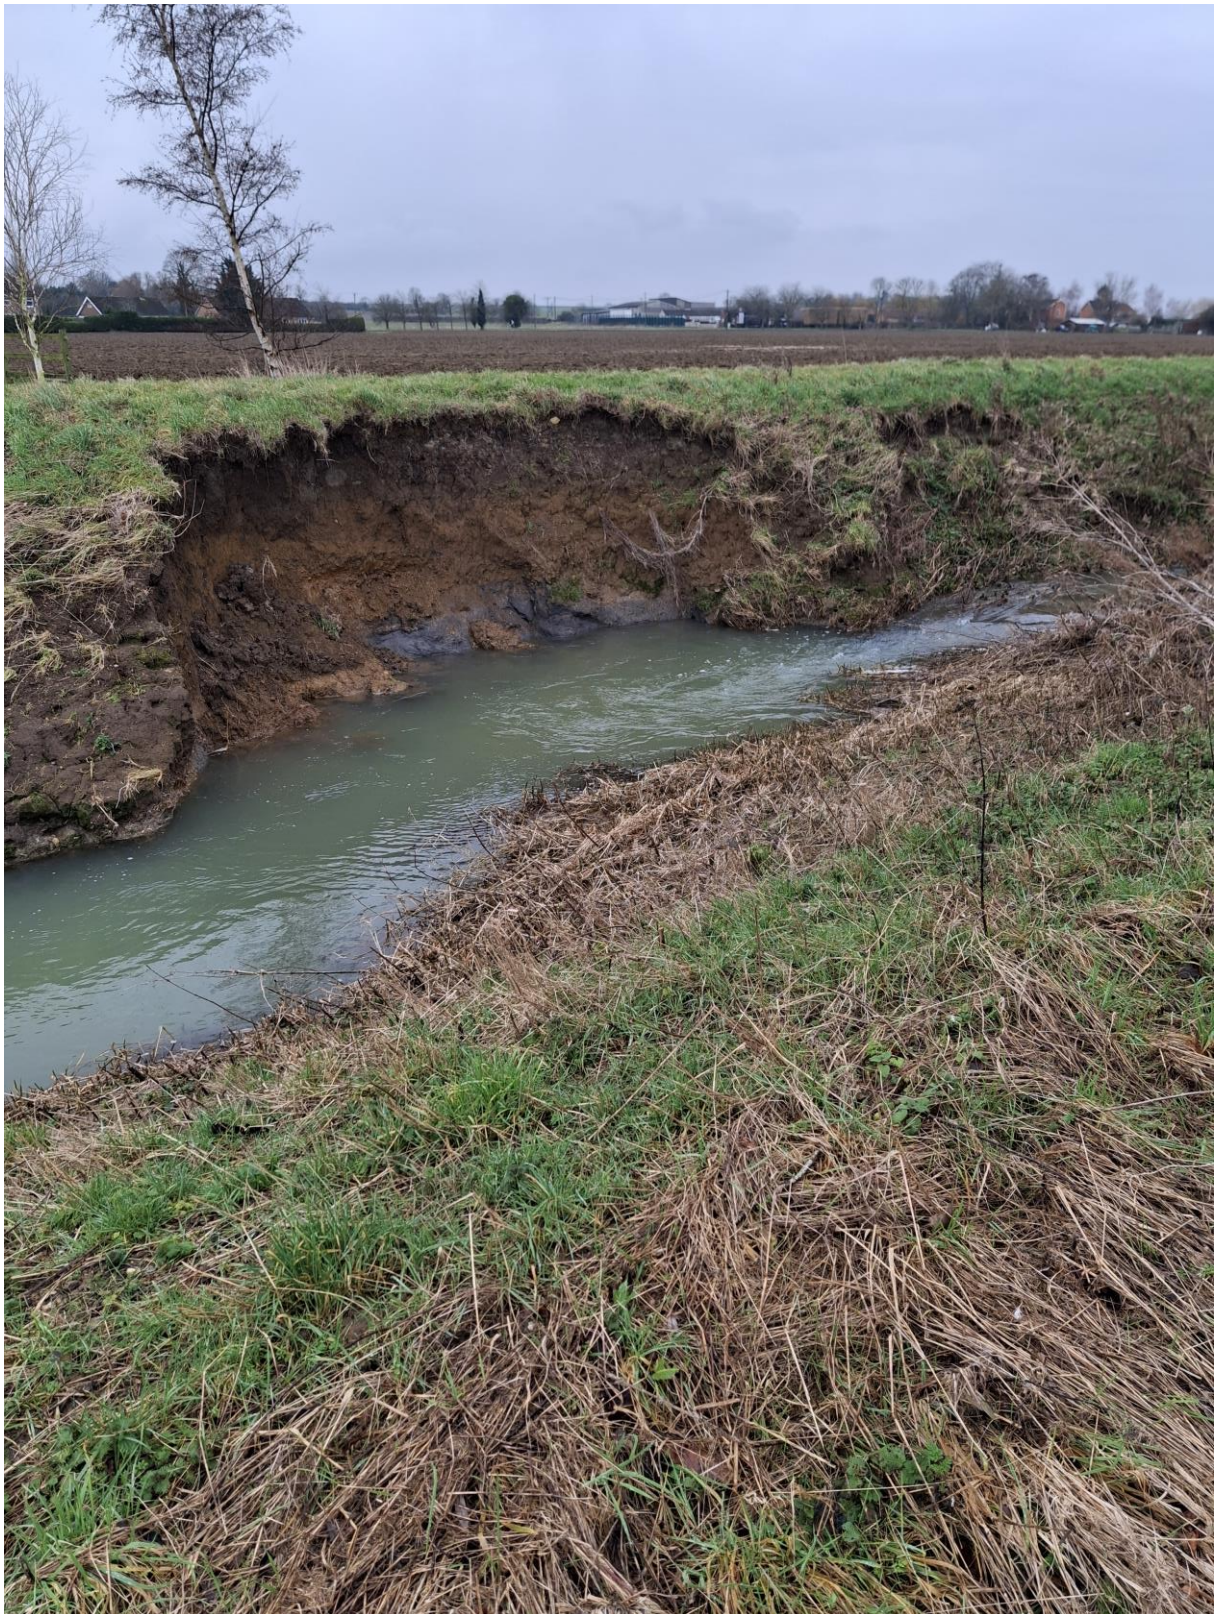
Furthermore, as part of the walkover, a visual inspection of the Ousemere Lode and its associated embankment was made. Whilst there were noted areas of subsidence (Photograph 7 in Appendix 7.3) flooding is understood not to have overtopped the southern bank and therefore shall not be commented upon further.

Photograph 7 – Subsidence of embankment) (Taken by GeoSmart Consultant, 12 February 2025).
