Ousemere Lode, Billingborough

Flooding 6th January 2025 – Evidence Based Review

Date: 9th May 2025

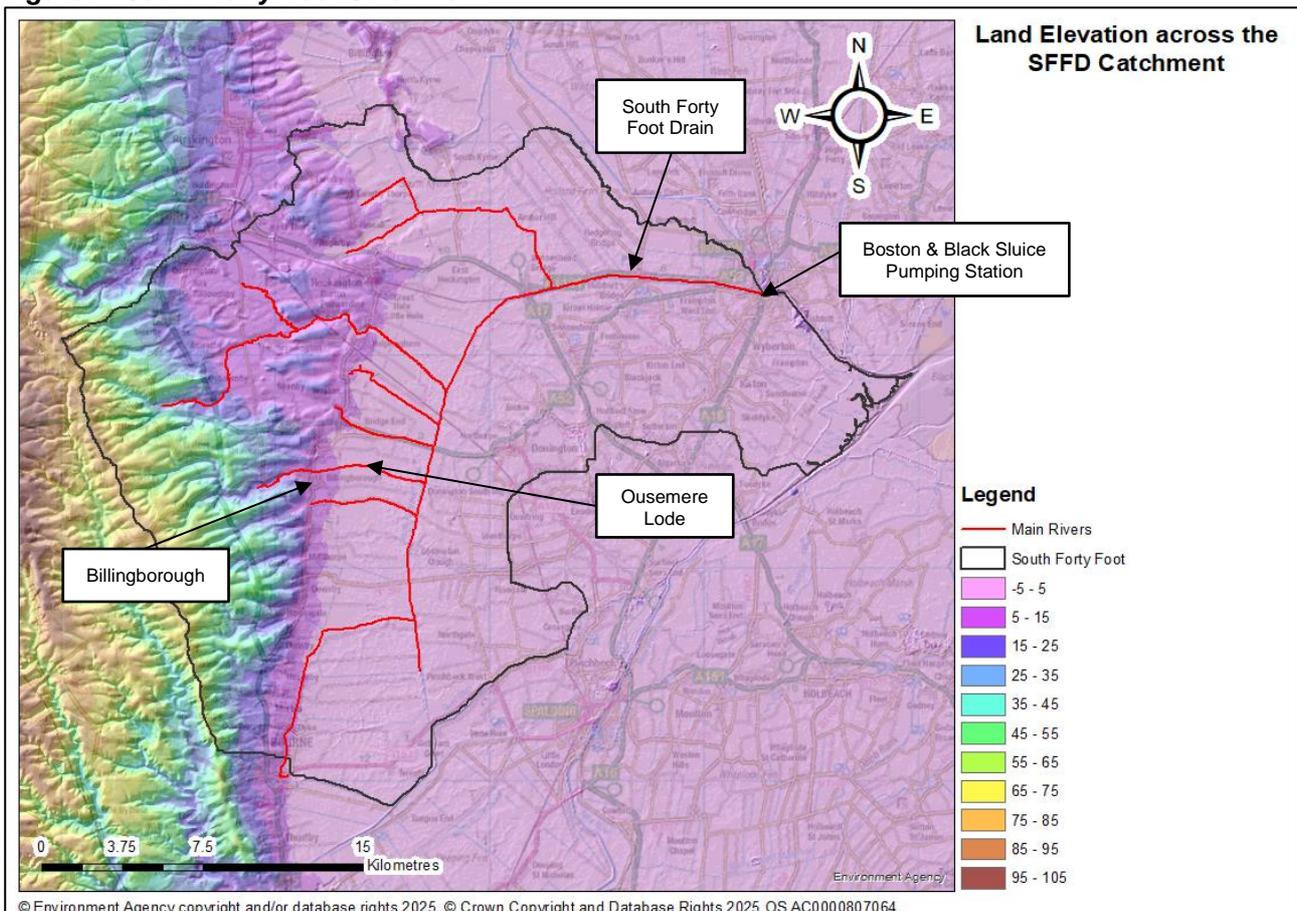
Figure 1: South Forty Foot Catchment

Billingborough is a small village located within the South Kesteven District Council of Lincolnshire, England with an approximate central National Grid Reference TF 116 342. The village has been subject to a long history associated with flooding dating back 200 years. It is situated within the South Forty Foot Drain Catchment (Figure 1) along the spring line of the historic Fen also known as the “Fen Edge” at around the 10m contour level sitting up above what would have been natural water levels in the Fen.

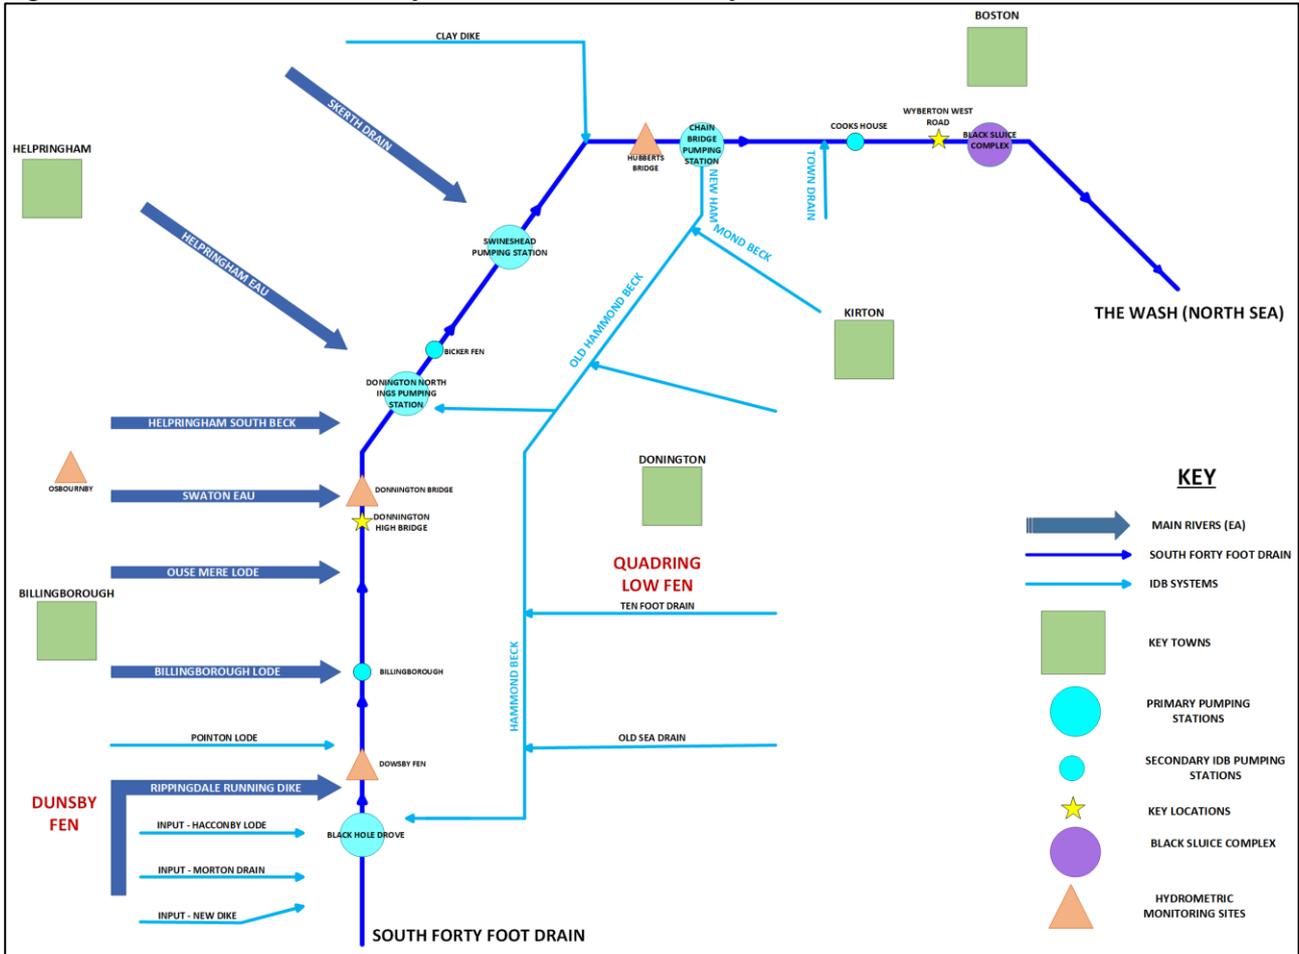
Figure 2: Schematic of all the key rivers in the South Forty Foot Drain Catchment

The Ousemere Lode (Figures 2 and 3) (*waterbody ID: GB105030056490*) is a designated main river under the regulation of the Environment Agency (red line) east of Folkingham with the upper reaches being classed as an ordinary watercourse and under the regulation of South Kesteven District Council.

The Ousemere Lode sources from the west in the fenland uplands at an elevation of around 73mAOD meandering through fields west of the A15 near Pickworth, flowing easterly to Walcot, then in a southerly direction to Folkingham before heading east crossing under Folkingham Road (known as the Piperdam Bridge) and flowing around the north edge of Billingborough (at around 9 to 10m AOD) and through the fens discharging into the South Forty Foot Drain (SFFD) – see figure 2 below. The Ousemere Lode is approximately 17km in length. It has an open and unrestricted confluence flowing via gravity into the SFFD, which

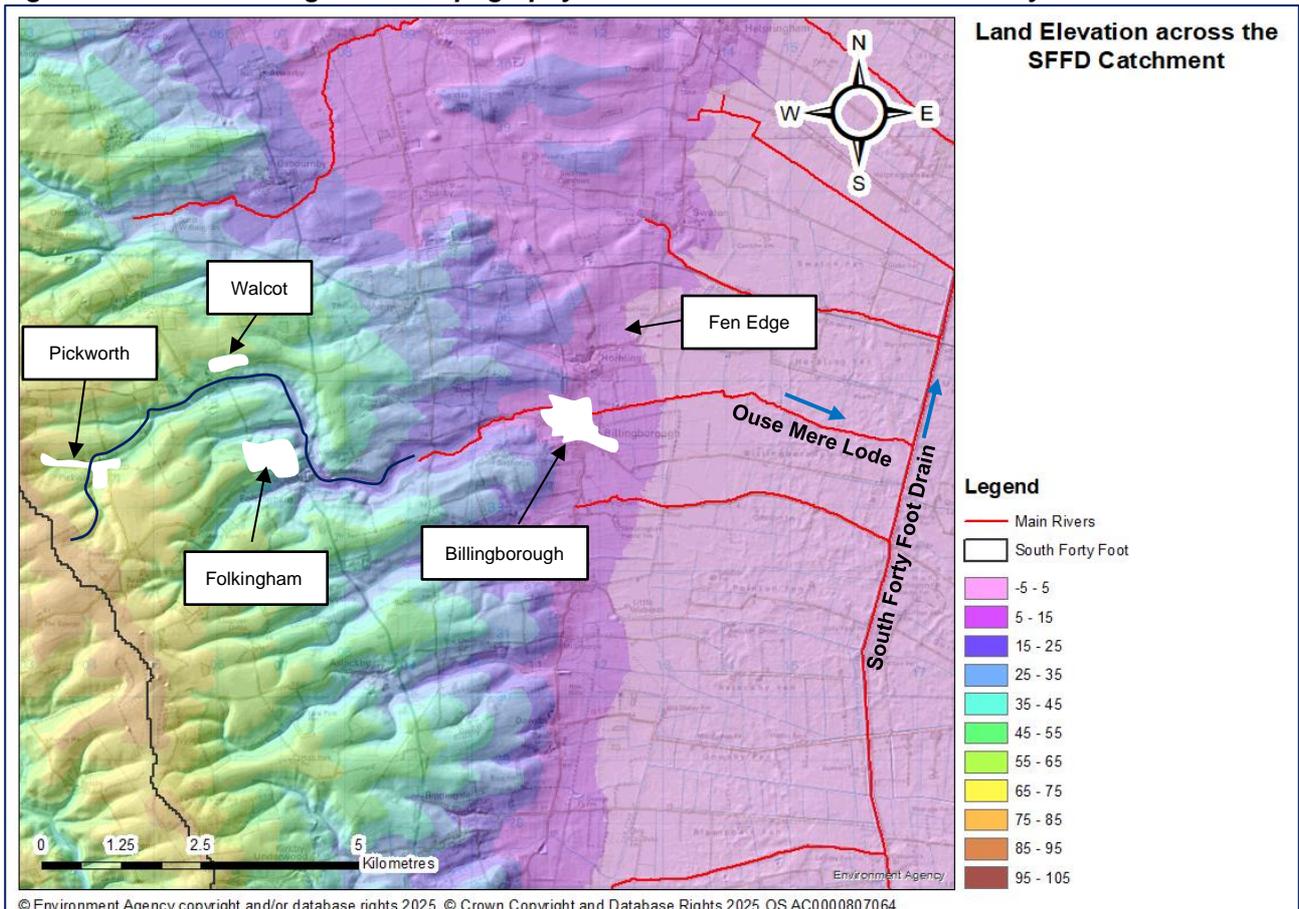
Figure 3: LIDAR showing relative topography for Ousemere Lode and South Forty Foot Drain

The Ousemere Lode has a combination of formal flood defence embankments, flood walls, engineered high ground and natural high ground on both sides throughout its 17km length. Specifically, to Billingborough the Environment Agency constructed an earth embankment in 2000 of c. 1.1km in length on the right-hand bank to the north of the village following flooding in 1998. The designed Standard of Protection (SoP) for the embankment was 1 in 25 meaning a 4% chance of flooding in any year. This is based on the embankment either failing or overtopping. However, over time this has been reviewed against newer modelling outputs and techniques which has meant the SoP has been reassessed. Based on the new modelling assessment parameters, the embankment is now classed as providing a minimum SoP of 1 in 100 meaning a 1% chance of flooding in any year.

The embankment begins after the watercourse passes under Piperdam Road Bridge and is continuous all the way to the flood wall just before Victoria Street meets the B1177. The raised embankments are cut twice a year with a weed cut in channel performed once a year. The channel itself is rich with gravels creating small riffles. There is a small section of engineered high ground and a flood wall past Victoria Street. The left-hand embankment from where the watercourse passes under Piperdam Bridge is classified as natural high ground. In extreme events, it is expected that the channel along this stretch of the river overtops the left-hand bank onto the floodplain. In addition to Ousemere Lode, the catchment is also drained via a local drainage network that includes field and roadside ditches as well as culverted drains in Billingborough itself. Following this network down Folkingham Road towards the old railway embankment, some of the ditches are open with access bridges to properties. Some have been filled in over the years. The access bridges to properties have a small pipe running underneath to allow water to pass between the ditches either side. At the time of our initial investigations, in some cases, it appeared flows may be impeded within ditches and/or through culverts due to debris accumulation.

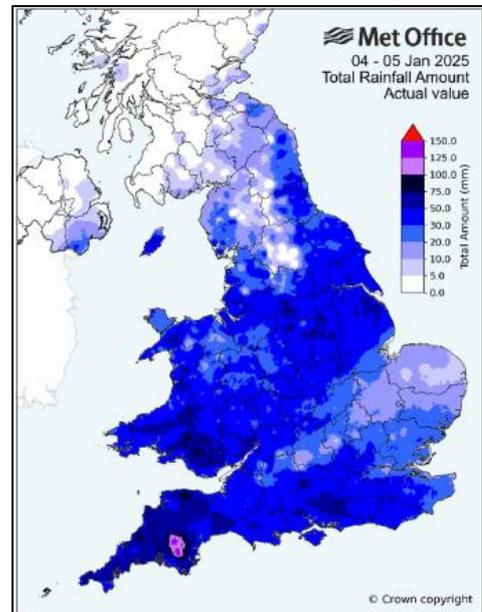
Figure 4: National rainfall 4th to 5th January 2025

The period from late December 2024 to early January 2025 brought some very wet and windy weather, with significant cold spells and snowfalls across upland areas in the north. Several long-running stations in eastern England recorded their wettest January day on record on the 05 January. 30 to 50mm of rain fell very widely across the country. The very wet weather was accompanied by some strong winds and near freezing temperatures and rain fell on extremely saturated and frozen ground. The heavy rain between the 04 to 06 January led to significant flooding problems. Worst hit areas included parts of Leicestershire and Lincolnshire with major incidents declared (Figure 4 - Map (Met Office, 2025)).

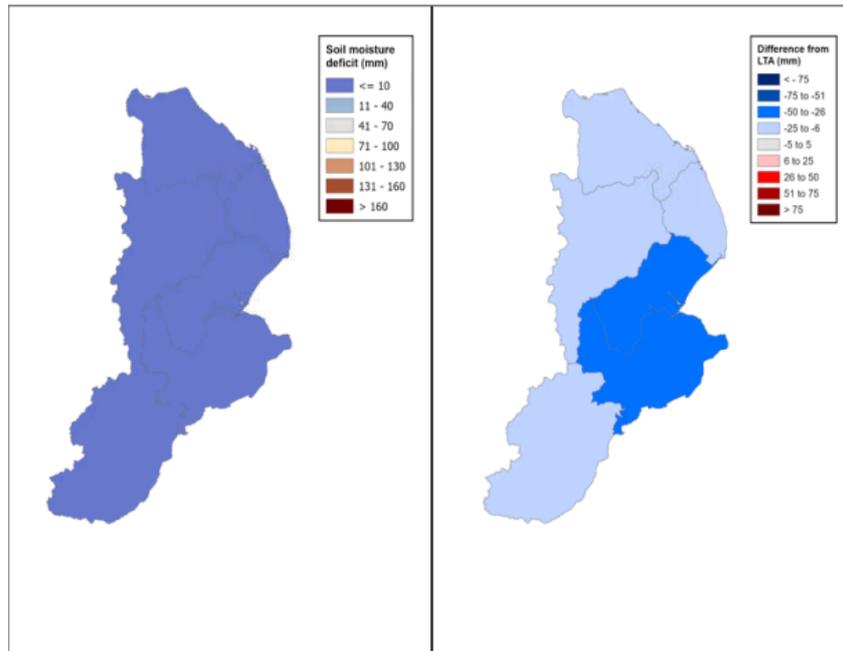
Figure 5: Lincolnshire Soil Moisture Deficit during December 2024 compared to the long-term average

The ground conditions across the catchment were already saturated (Figure 5). The soil had the capacity to absorb less than 5mm of rainfall (known as the soil moisture deficit). Temperatures overnight on the 5th and 6th January were around 0°C and snow had fallen on the higher ground, meaning the surface of the ground was frozen and, in some places covered with a layer of snow. Vegetation cover in January is significantly reduced, with no leaves on trees. These factors resulted in rainfall running overland and straight into watercourses rather than infiltrating into the ground and reaching watercourses at a slower rate. This caused rapidly rising river levels and flooding.

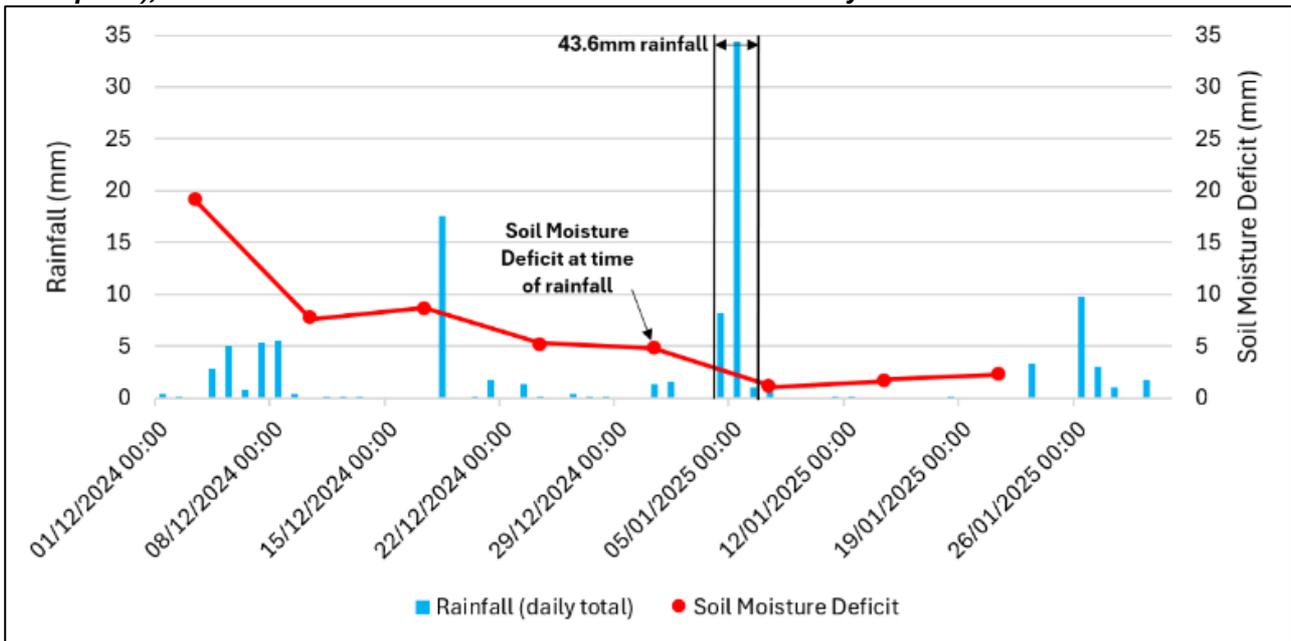
Figure 6: Rainfall daily totals (mm) and Soil Moisture Deficit (SMD) (ground capacity for water absorption), Ousemere Lode Catchment December 2024 to January 2025

The Billingborough area recorded 43.6mm of rainfall at the Osbournby Rain Gauge between the 4th to the 6th of January 2025. Of this total, 32mm fell in 9.5 hours between 22:15 on 5th January and 09:45 on 6th January. This rainfall fell onto already saturated and frozen ground meaning the ground had limited capacity to absorb further water. The ground conditions had less than 5mm of absorption (measured as ‘Soil Moisture Deficit’ (SMD)) available to soak into the ground. Rainfall and SMD are shown in Figure 6 below.

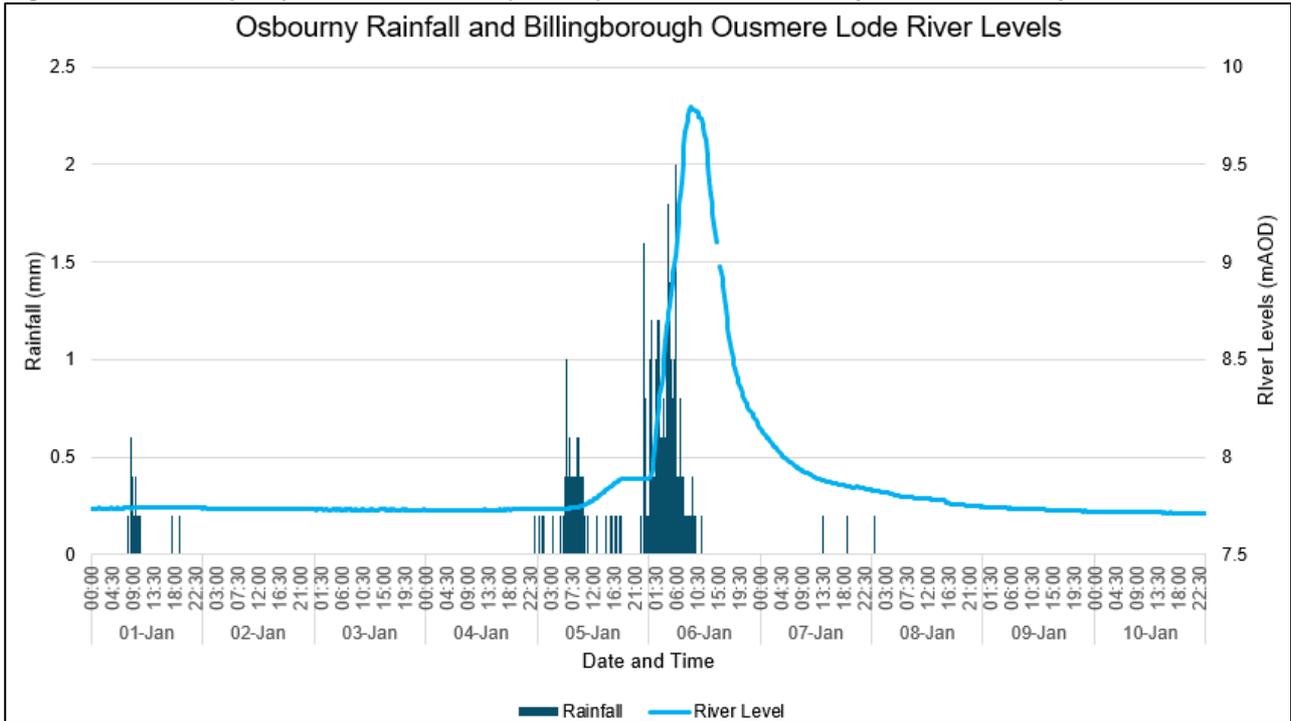
Figure 7: Rainfall (mm) and River Level (mAOD) between 1st January and 10 January 2025

The Ousemere Lode response to the rainfall event resulted in the watercourse recording its highest ever level at Billingborough Gauging Station (NGR TF1173434506). The watercourse peaked at 9.79 metres Above Ordnance Datum (mAOD) (also referred to as above sea level) at 09:00 hours on 6th January 2025 (Figure 7).

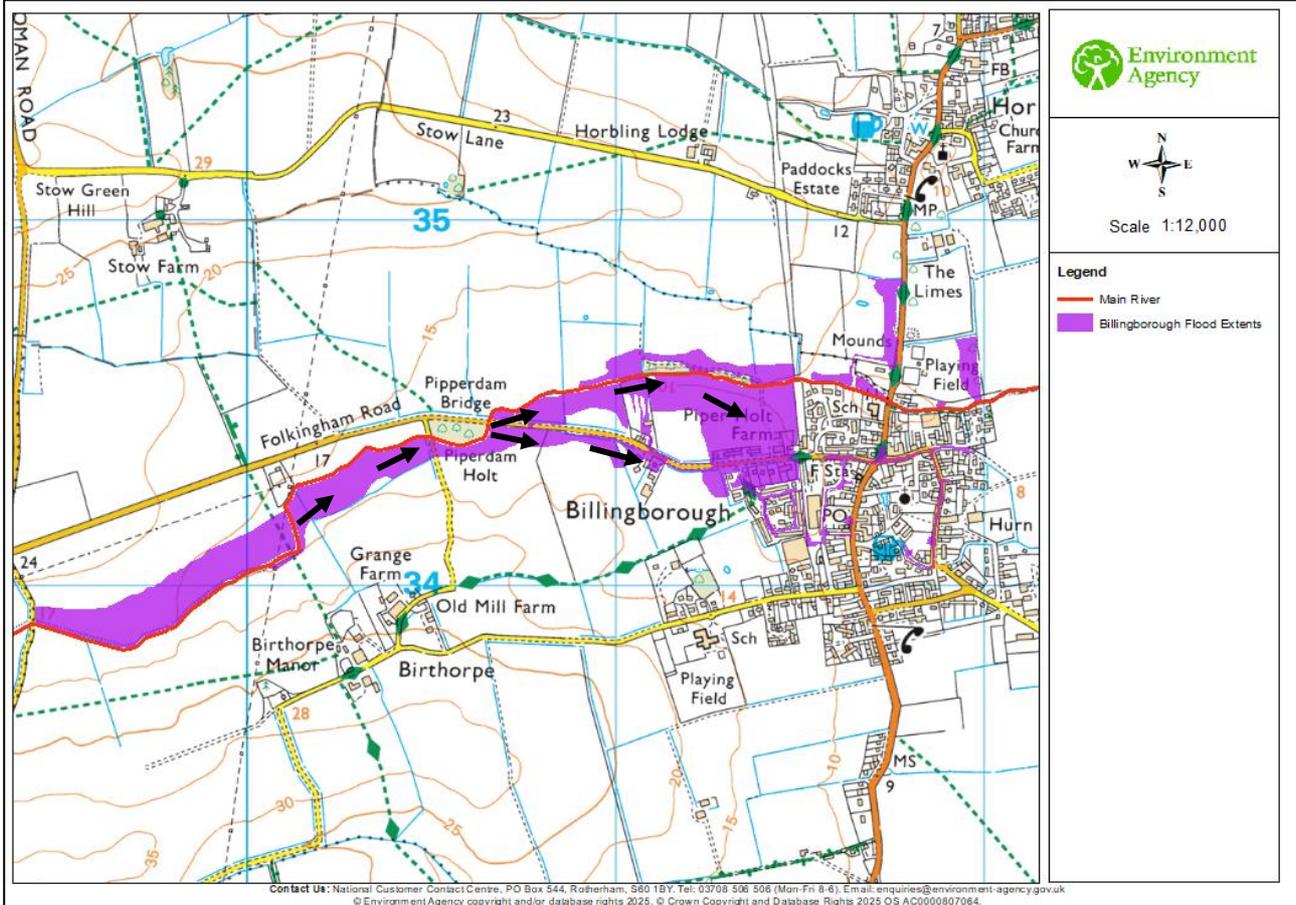
Figure 8: Flood extent and main river overland flow paths, Ousemere Lode, Billingborough, January 6th, 2025

Evidence shows the Ousemere Lode flowed overland and across both Mareham Lane and Oseby Lane. Significant accumulations of debris, mainly straw in the fields, showed the path of the floodwater. The valley like topography, funnels the water east, down towards the Ousemere Lode and towards Billingborough. Ultimately, the Ousemere Lode exceeded its channel capacity between Mareham Lane and Oseby Lane (approximately NGR TF1013434129) and further downstream before Piperdam Road Bridge (NGR TF1064834410). Excess water came out of the channel and flowed across the natural floodplain, remaining out of channel as it reached the Piperdam Road Bridge. The road bridge did allow water to flow beneath the soffit level but given the high river level, water was already out of channel at this point and therefore flowed east along the field adjacent to Folkingham Road.

The floodwater pooled and entered the drainage ditches, spilling across Folkingham Road, into the field to the north and across the floodplain taking its natural flow path flowing down the highway, further overwhelming roadside ditches and crossing fields before pooling at the lowest point on Folkingham Road. Whilst water could not re-enter the Ousemere Lode from the fields north of Folkingham Road due to the flood embankment, it must be noted had the embankment not been in place, it is highly likely a significant amount of additional water would have spilled onto the floodplain from the river. This would likely have further increased the depth and extent of flooding in Billingborough. There is also evidence of water flowing over the bridge at Piper Holt Farm in Billingborough from debris positioning on site.

Figure 8 shows the flood extent and estimated flow path directions.

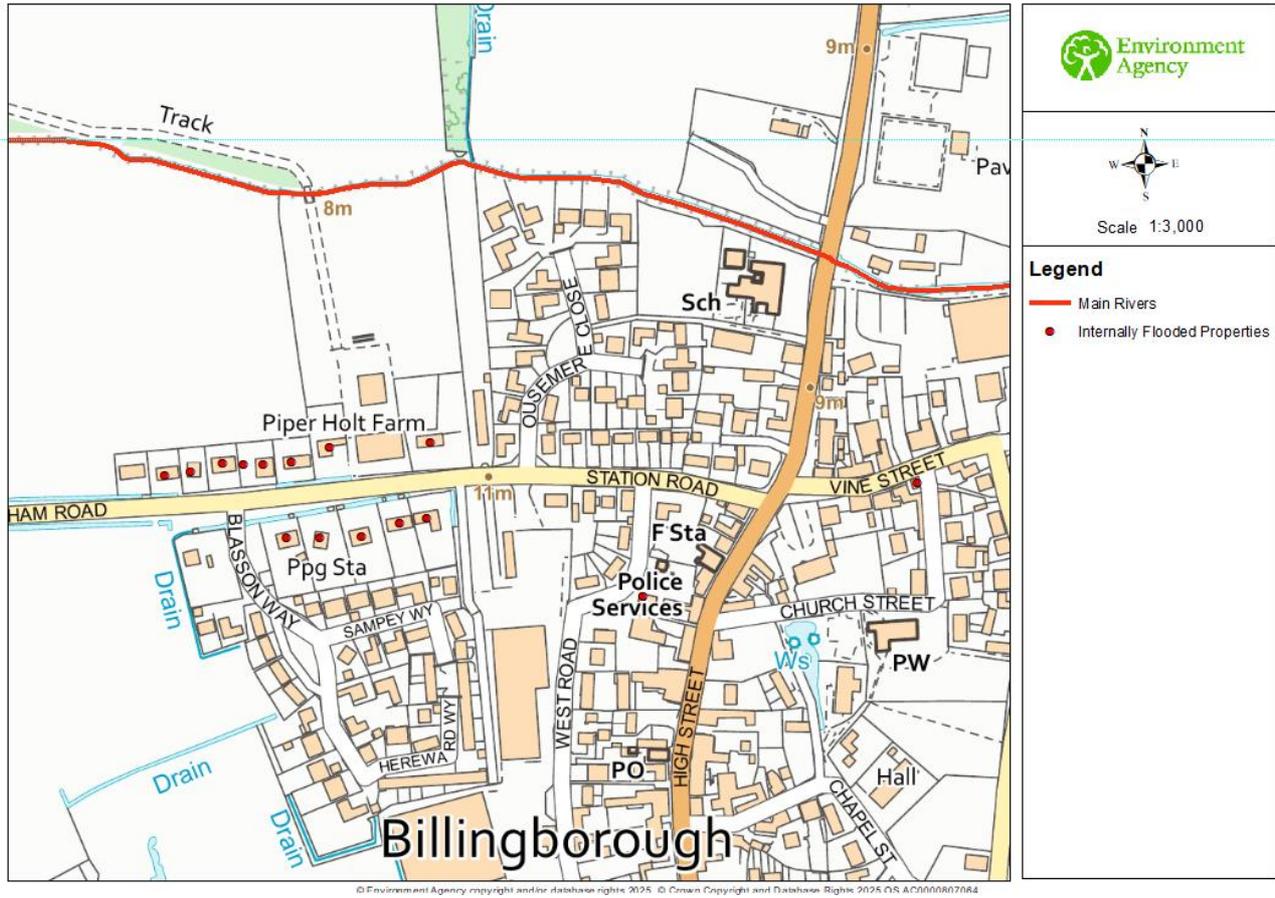
Figure 9: Internal property flooding Billingborough, 6th January 2025

Much of the flood water pooled on Folkington Road (up to 0.8m deep), High Street, West Road, Low Street and Vine Street/Court. Flooding impacted 15 properties, 13 on Folkington Road, one on West Road and one on Vine Court/Street as well as highways, drainage networks and surrounding land (Figure 9 and 10). Folkington Road, Blasson Way, Low Street, West Road High Street and Vine Street were all reported as being impassable on 6th January with Folkington Road still so on 7th January. Issues with sewer flooding were also reported by some residents.

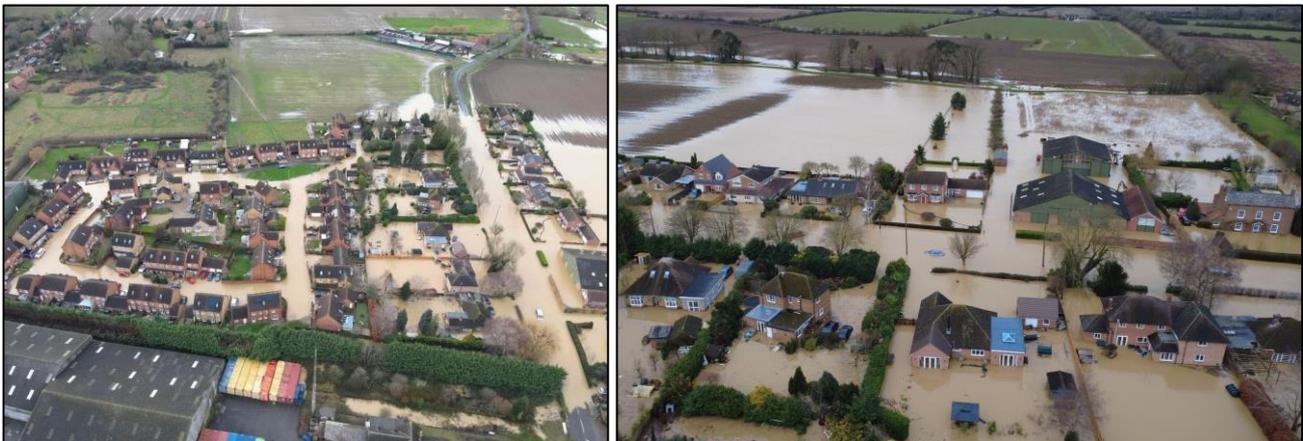
Figure 10: Flooding on Folkingham Road area Billingborough, 6th January 2025 (source - left unknown, right K. Brown)

At around 05:00hrs, residents observed water flowing onto Folkingham Road west of Blasson Way. At around 06:30hrs, water was seen flowing down Folkingham Road and by 07:30hrs, the drainage ditches on Folkingham Road were full with Ouseby Lane being impassable due to overland flows. By 08:00hrs, multiple properties along Folkingham Road reported being flooded internally or cut off and by 09:30hrs, Folkingham Road was completely impassable to both vehicles and residents. Further highway flooding was

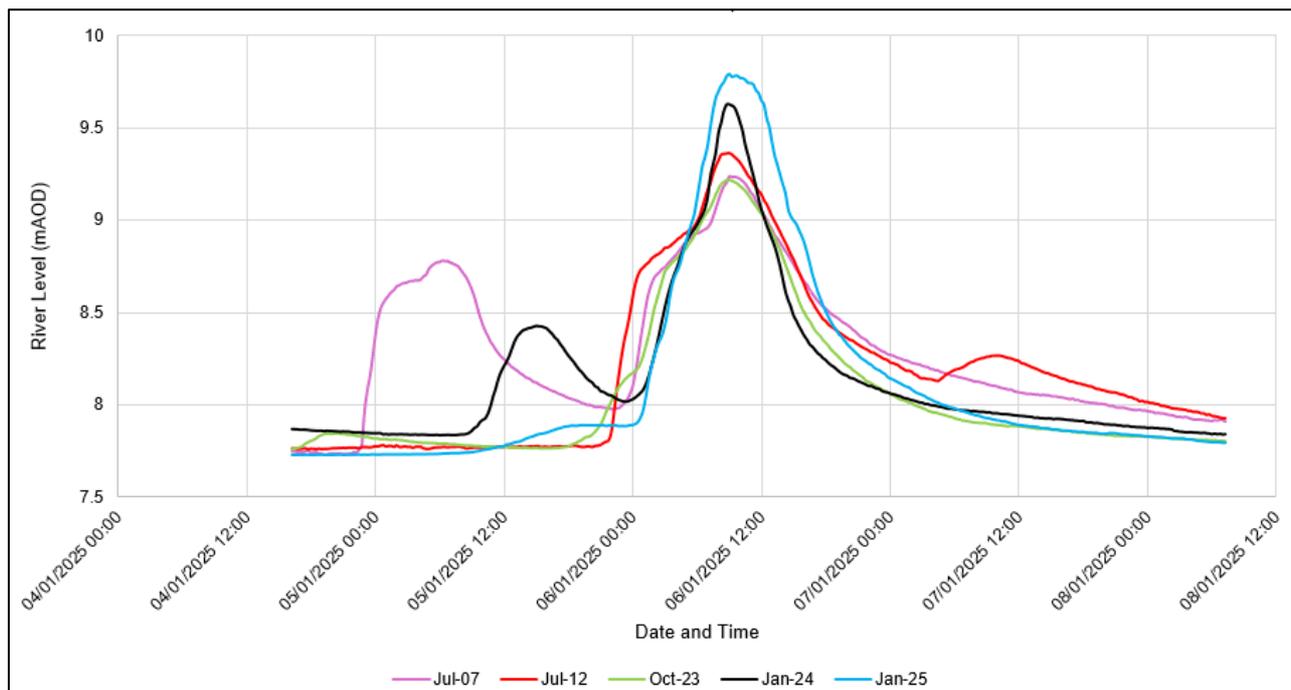
Figure 11: Comparison of peak rivel levels in Ousemere Lode with January 2025

The quantity of rain that reached the Ousemere Lode, in a short period of time, led directly to the river exceeding its channel capacity. The river level reached was around 0.16m higher than Storm Henk in January 2024 and 0.57m higher than Storm Babet in October 2023 (Figure 11).

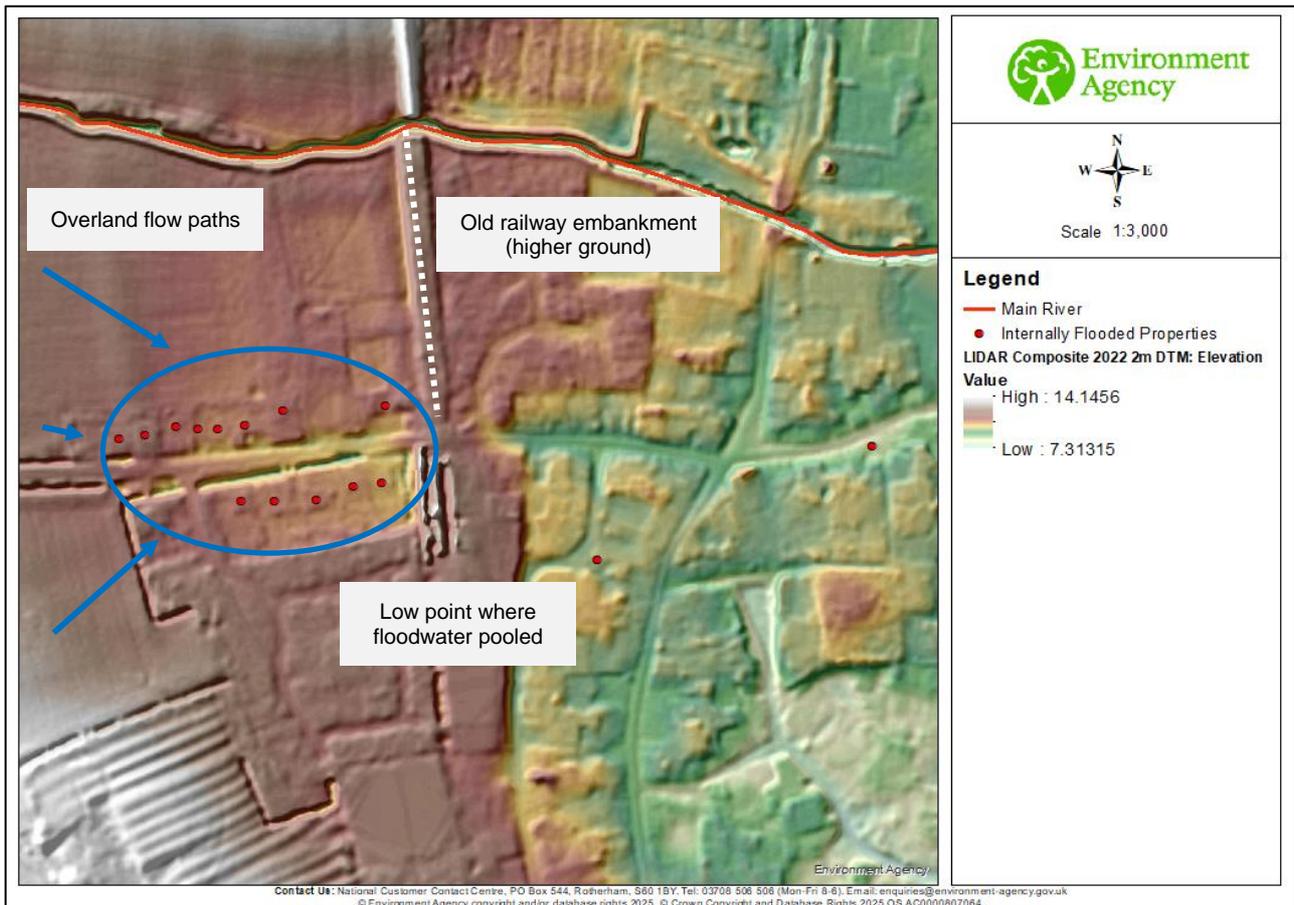
Figure 12: Land elevations in Billingborough showing low spot where flood water pooled

Given the extent and depth of flooding that occurred, it is believed the primary but not the first source of flooding that reached residential properties in Billingborough was from the Ousemere Lode evidenced by both photographs and a significant accumulation of straw debris within the fields as floodwater pooled and backed up.

- It is possible that the depth and period of flooding on Folkingham Road may have been reduced if the floodwater had been able to drain away via the culvert under the old railway embankment, via adequately maintained roadside ditches and into Ousemere Lode once the river levels receded.

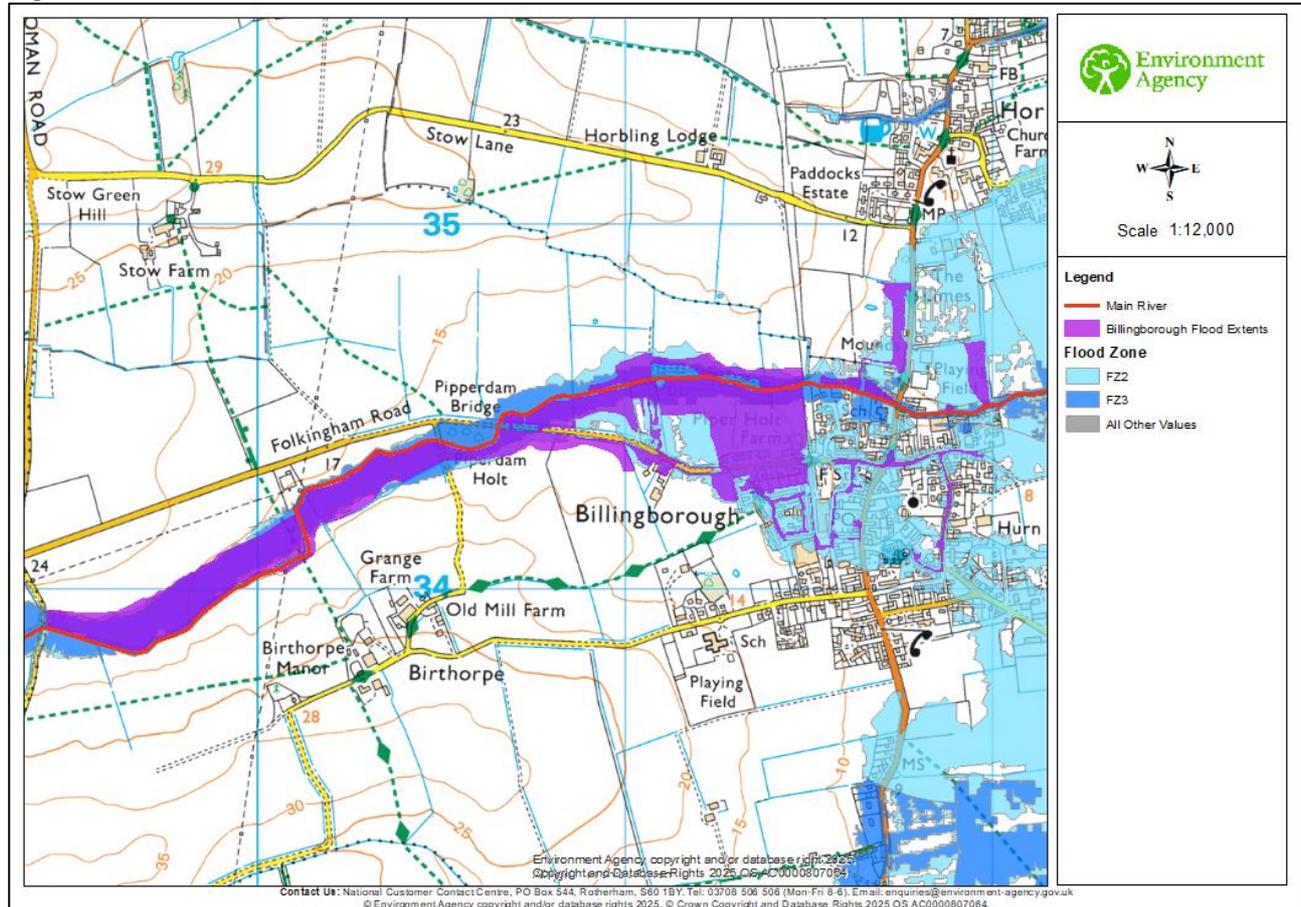
Figure 13: Actual flood extent overlaid on the extreme flood outline

The volume and extent of overland flows observed aligns with the predicted extreme flood outline (1 in 1000 (0.1%) annual chance plus climate change flood extent) (Figure 13). The Ousemere Lode utilised its natural floodplain, flowing easternly towards Billingham, and covered a large area of floodplain as a result of the extreme flood event.

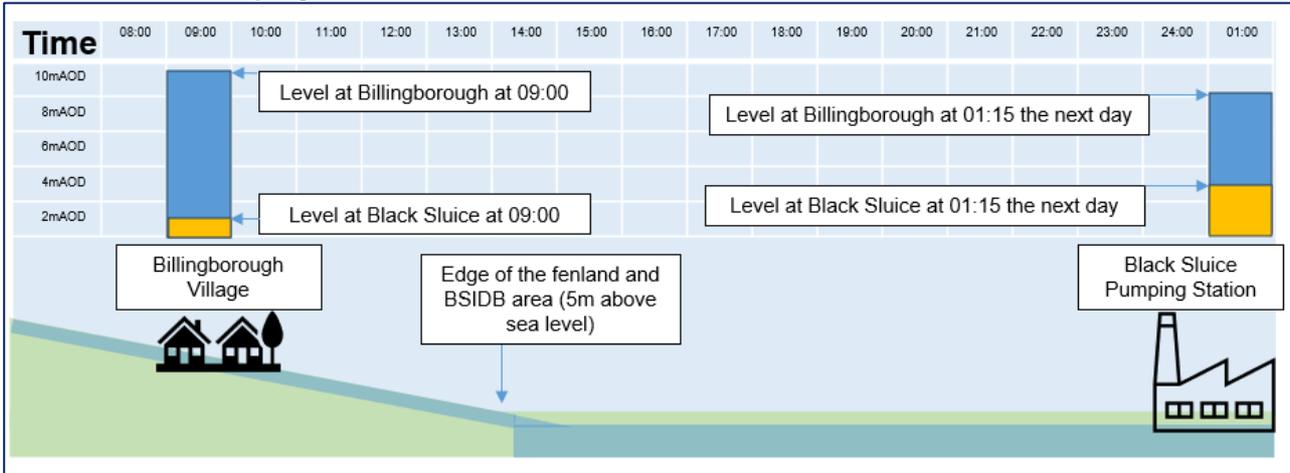
Figure 14: Relative timings and river levels between Ousemere Lode and the South Forty Foot Drain at Black Sluice Pumping Station

The Ousemere Lode at Billingham reached its record peak of 9.79m above sea level at 09:00hrs on the morning of the 6th of January 2025. Reports of homes flooding were received before this at 07:30hrs. At the same time, levels in the South Forty Foot Drain at Black Sluice Pumping Station were much lower at 1.04m above sea level. Levels did not rise, and peak at Black Sluice Pumping Station (around 3.0m above sea level), until 01:15hrs on the 7th of January 2025, more than 16 hours later. By this time, levels had dropped in the Ousemere Lode through Billingham by 1.69m, as water had been able to flow towards the South Forty Foot Drain and discharge without restriction (Figure 14).

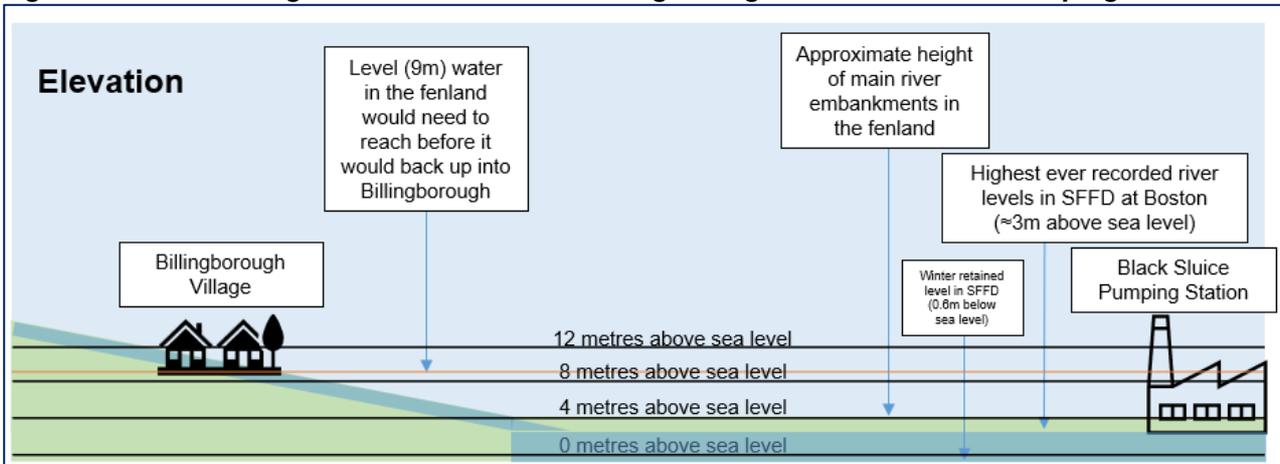
Figure 15: Relative heights above sea level of Billingborough and Black Sluice Pumping Station

The diagram below shows the relative heights above sea level of the pumping station and Billingborough. For water backing up in the South Forty Foot Drain to affect Billingborough, it would need to rise to the level of the village. This would be around 6m higher than the highest ever recorded levels in the South Forty Foot Drain, by which point the entire Fenland area of South Lincolnshire would be under 5-6m of flood water (Figure 15).

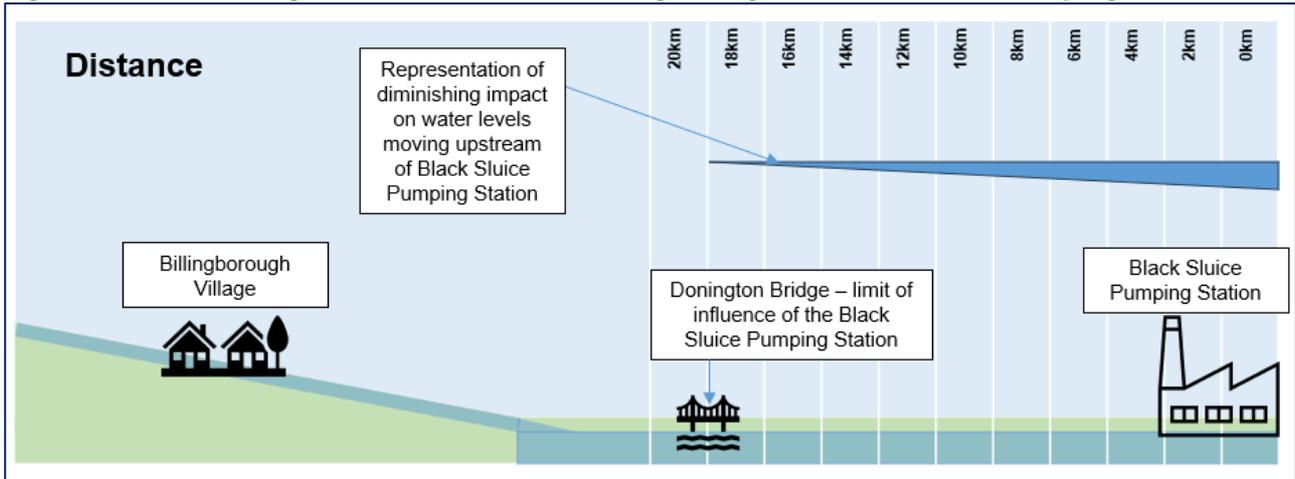
Figure 16: Relative heights above sea level of Billingborough and Black Sluice Pumping Station

The Black Sluice Pumping Station is around 27km downstream of Billingborough. When the pumping station was operated in the past, the effect that could be observed on levels diminished as you moved upstream away from the station. The effect of pumping became unnoticeable upstream of Donington Bridge, which is around 20km from the pumping station. Therefore, anything further upstream than Donington Bridge does not benefit from the pumping station running. Billingborough is a further 7km upstream of Donington Bridge where the benefit stops and therefore pumping at Black Sluice has zero effect (Figure 16).
