S19-948

**Folkingham Road,
Vine Street, West
Road,
Billingborough**

Section 19 Flood and Water
Management Act 2010

GeoSmart Information Ltd

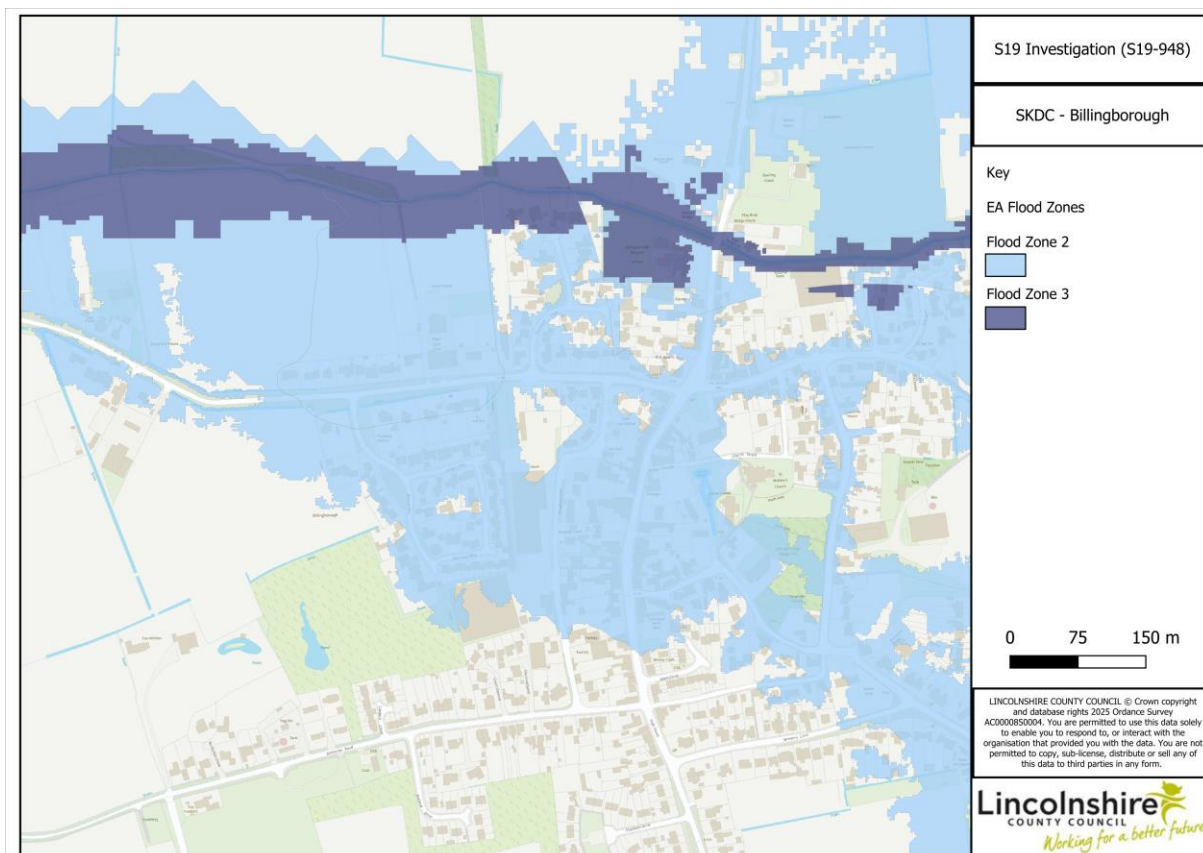
According to the EA's Flood Map for Planning Purposes, the Properties are all located with Flood Zone 2, indicating they have a Medium probability of flooding from rivers (Figure 3).

(Figure 3 - Flood zone mapping in the area surrounding the affected properties)

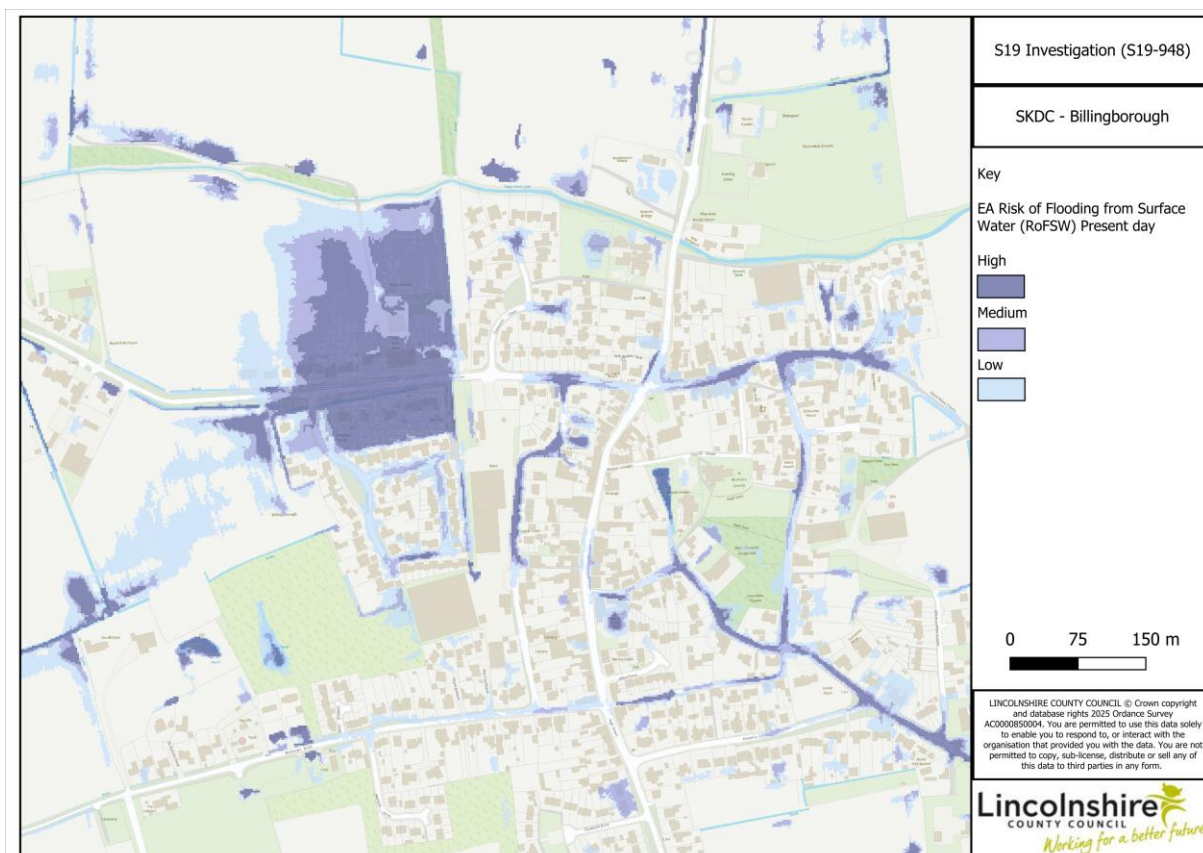
According to the EA's Surface Water Flood Risk mapping (Figure 4), Properties A – K are at a High risk of pluvial flooding. Property L is at a Medium risk of surface water flooding, while Property M is assessed as Very Low to Medium risk, with flooding modelled to affect the southern and western face of the dwelling.

(Figure 4 - Surface water flood risk in the area surrounding the affected properties)

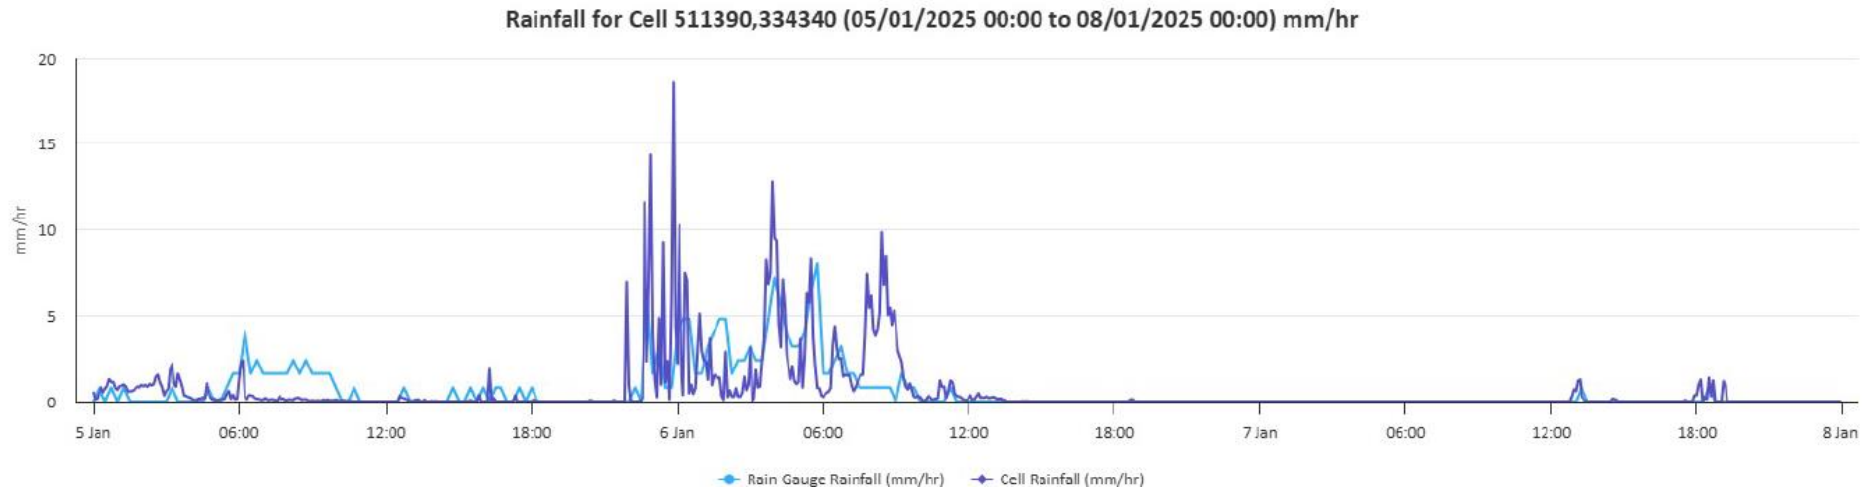
(Figure 11 - Rainfall intensities for Cell 511390, 334340, between 05 and 08 January 2025.)

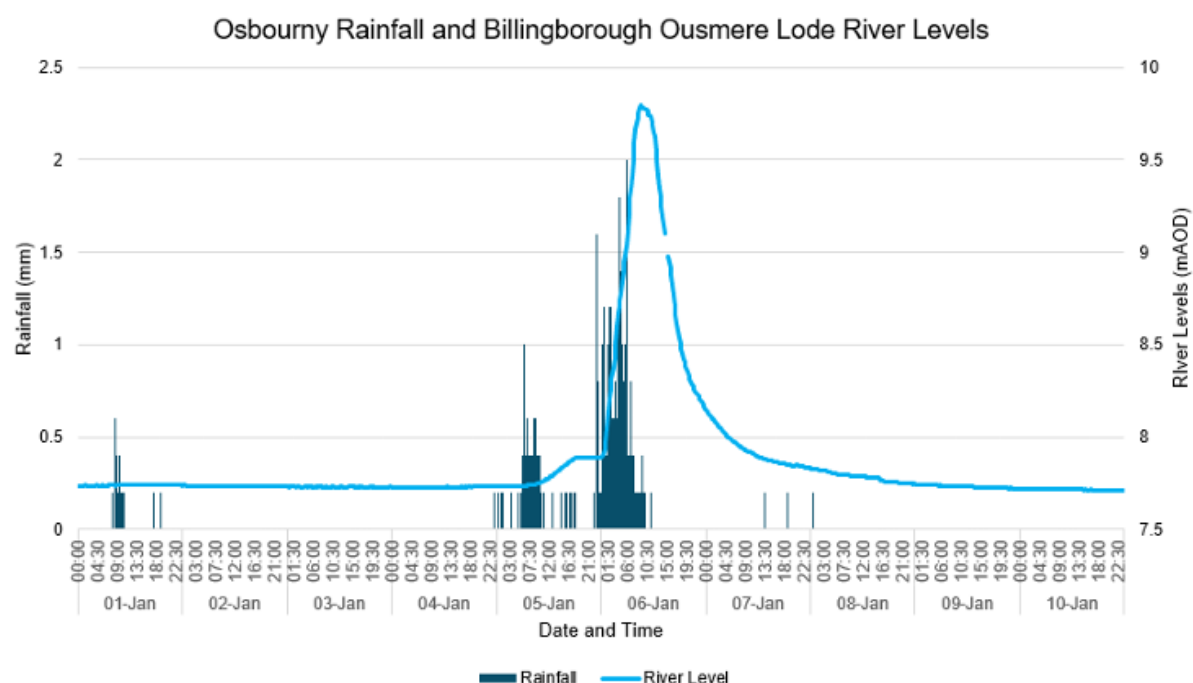
Based on the available data, typical river levels within the channel are around 7.75 mAOD. During the January 2025 flood event, levels began to rise following a brief period of intense rainfall on the morning of 05 January, reaching 7.90 mAOD at 12:00. At c. 01:30 on 06 January river levels within the Ousemere Lode rose rapidly to a peak level of 9.79 mAOD at 09:00 following the prolonged, intense rainfall described within Section 3.2.2. Subsequently, water levels gradually declined, returning to typical levels by approximately 15:00 on 09 January 2025.

(Figure 12 – Rainfall (mm) and river levels (mAOD) between 01 and 10 January 2025 at the Billingborough Gauging Station (NGR TF1173434506)- taken from the EA Evidence Based Review (May 2025)).

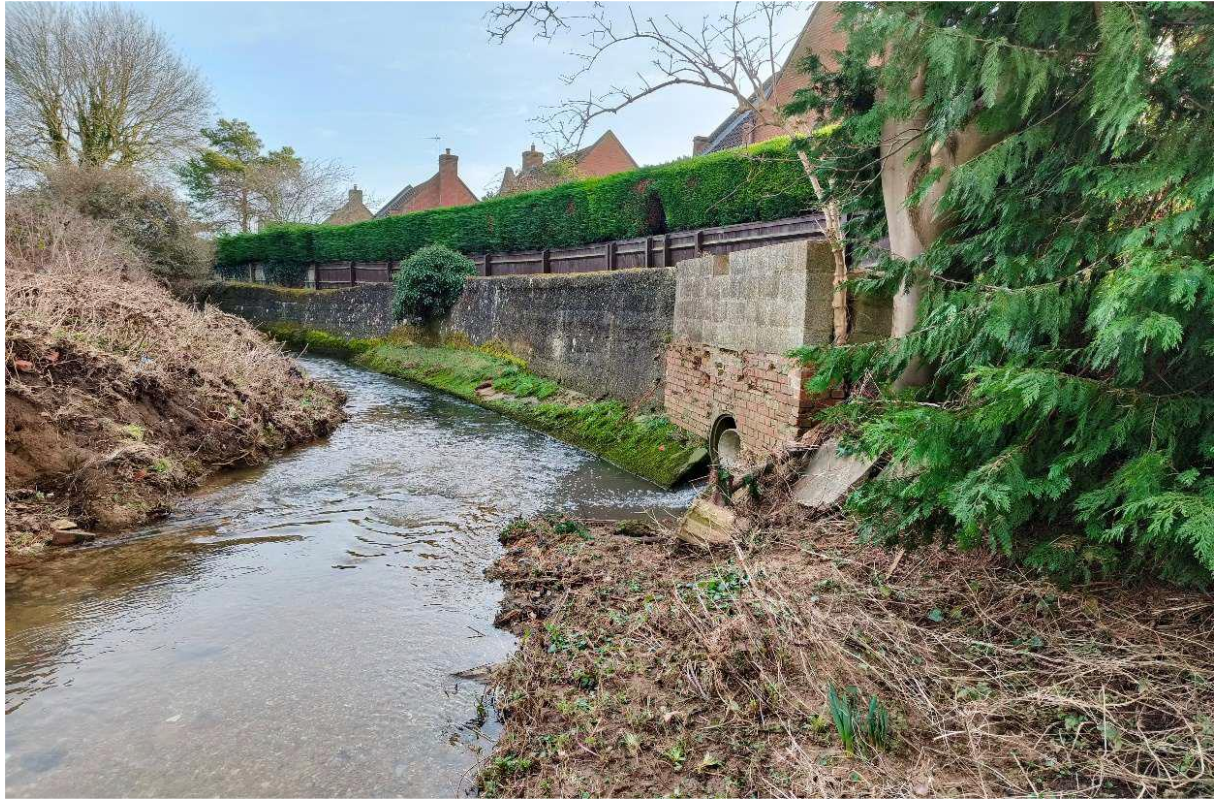
(Figure 21 - Surface water drainage discharge outlet into Ousemere Lode) (Taken by Billingborough resident, date unknown).

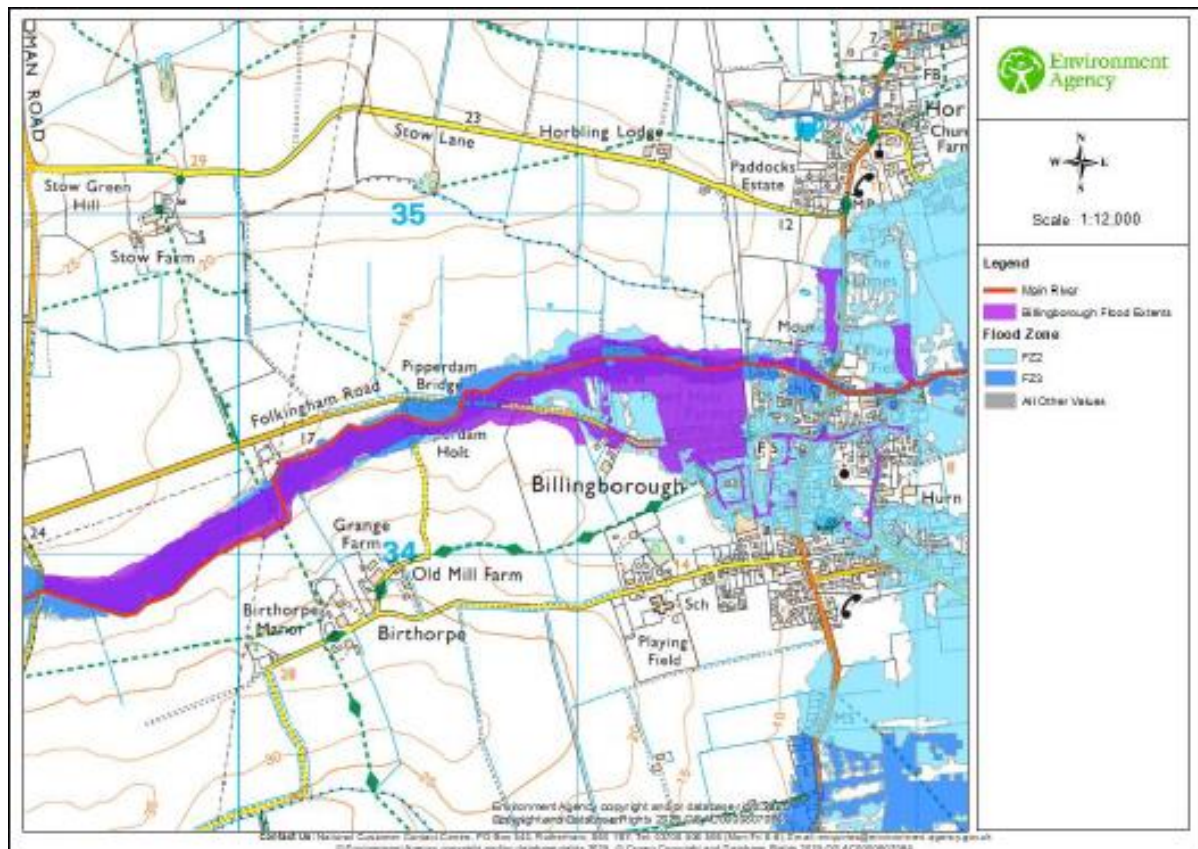
The EA's evidence based review (EA, 2025) displays the flood extents that occurred during the 6 January flood (Figure 24).

(Figure 24 - Reported Billingborough Flood Extents, as included within the Ousemere Lode, Billingborough, Flooding 06 January 2025 – Evidence Based Review (EA, 2025).

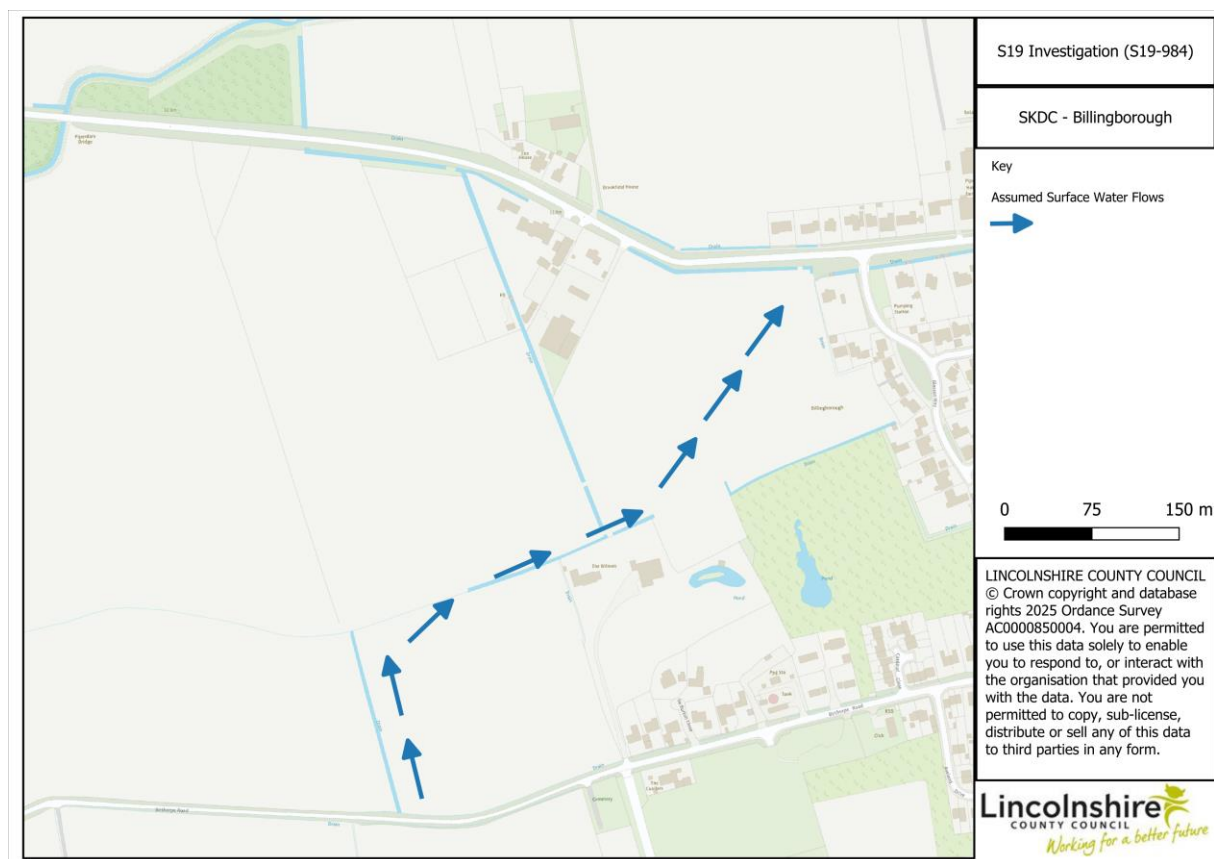
In conjunction with flooding from the Ousemere Lode, surface water runoff from the surrounding catchment is considered to have been a primary contributor to the flooding observed at the Site. The EA's review of the event indicates that overland flow originated from Birthorpe Road (Figure 25) and the surrounding higher ground, which is consistent with available topographic mapping. The extent of observed flooding broadly aligns with the EA's modelled pluvial flood outlines, highlighting the inherent surface water flood risk at Properties A -K.

(Figure 25 - Inferred surface water flows toward Folkingham Road).
